Passive Components Networking Symposium

Failure Analysis feedback From all markets

Eric ZAIA (Technical coordinator - Passive components and PCBA)
Béatrice MOREAU (Passive components & PCB Expert)

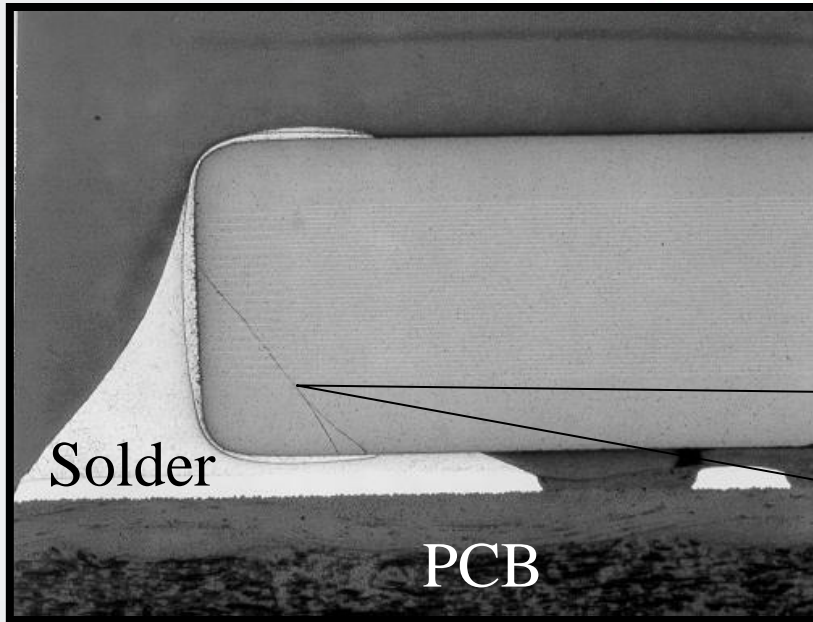
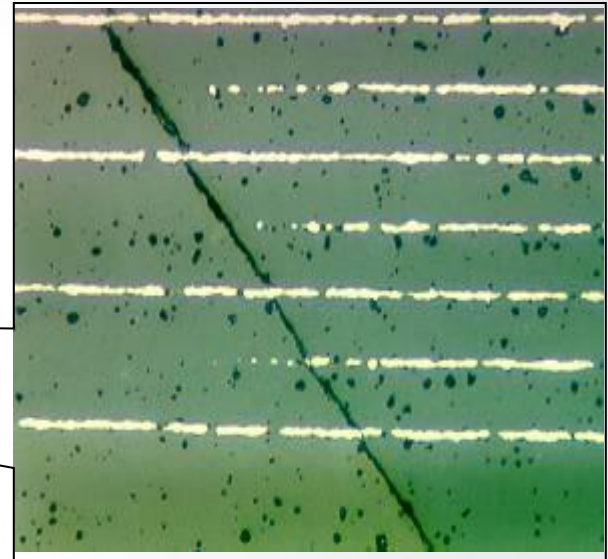
Diagonal cracks (@45°) due to Thermo and/or Mechanical stresses caused by soldering/testing/depanelization/handling...

→ Short circuit occurs when dielectric between opposite electrodes is cracked

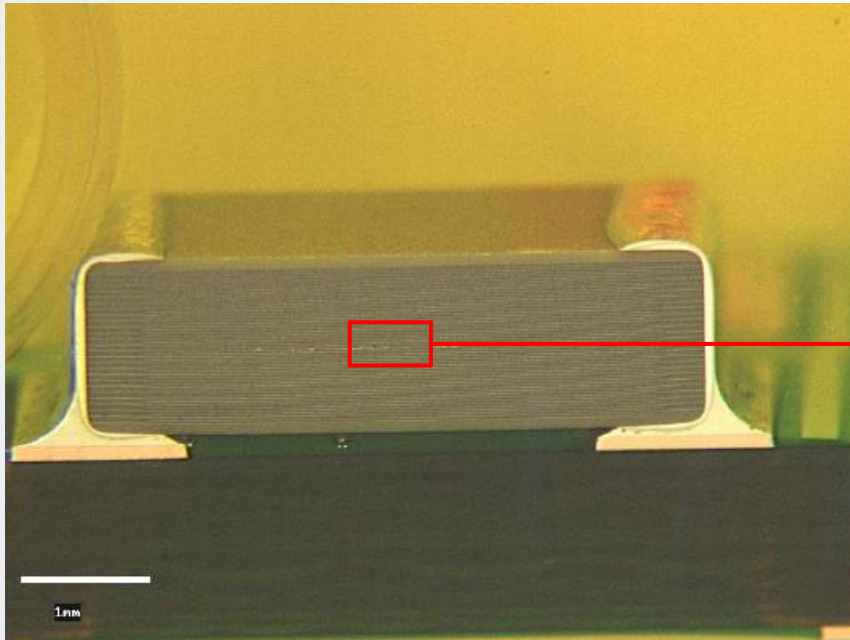
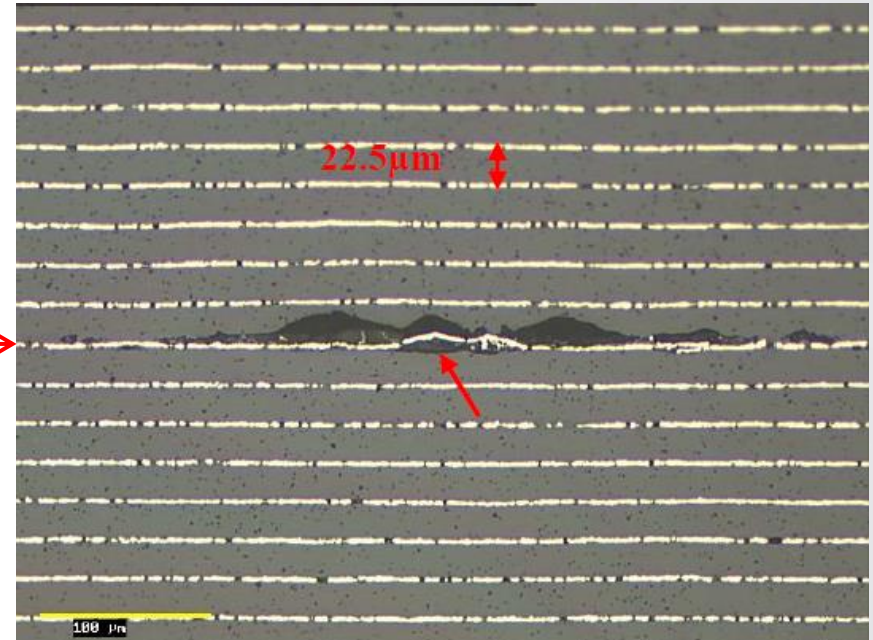
Ceramic Capacitors Delamination: Electrode/Ceramic

Delamination relative to the component process: Part lamination/sintering
→ **Results in insulation reduction up to Short circuit**

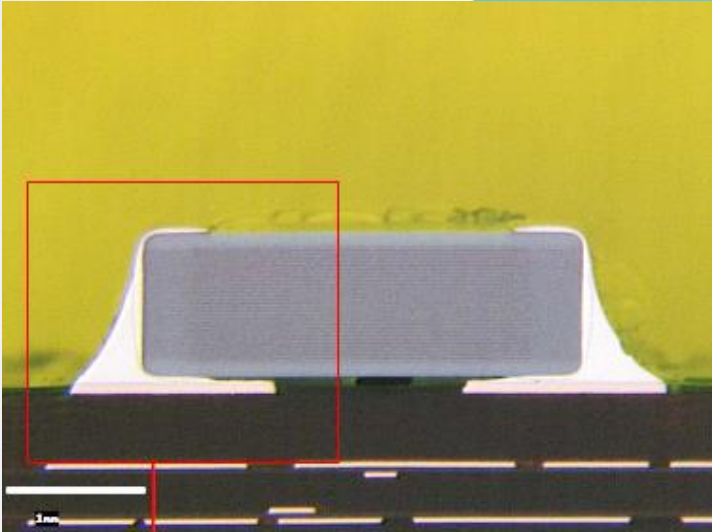
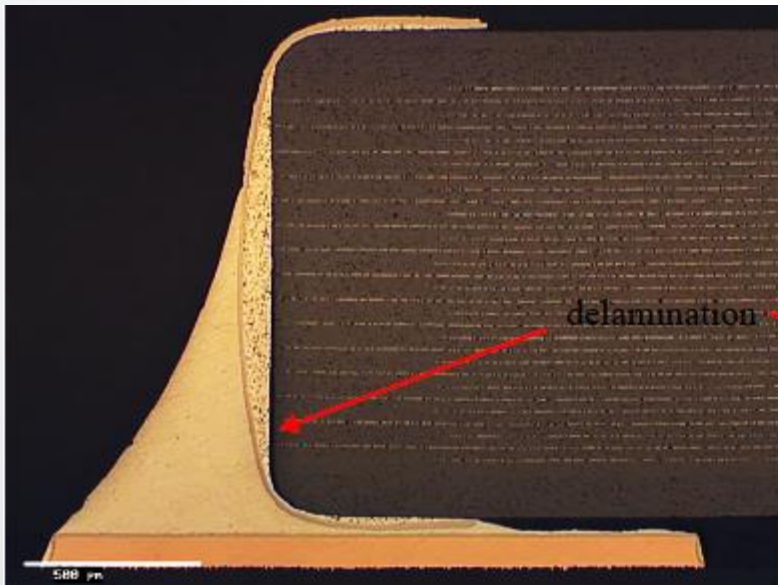
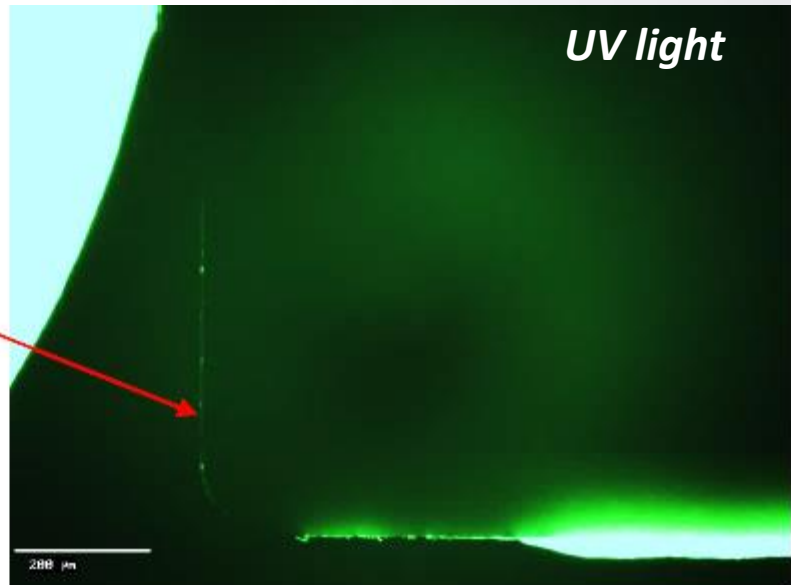
Ceramic Capacitors Delamination Electrodes/Termination

Soldering process + Component Weakness
(at termination)
Revealed after ageing test
→ results in loss of capacitance up
to Open circuit

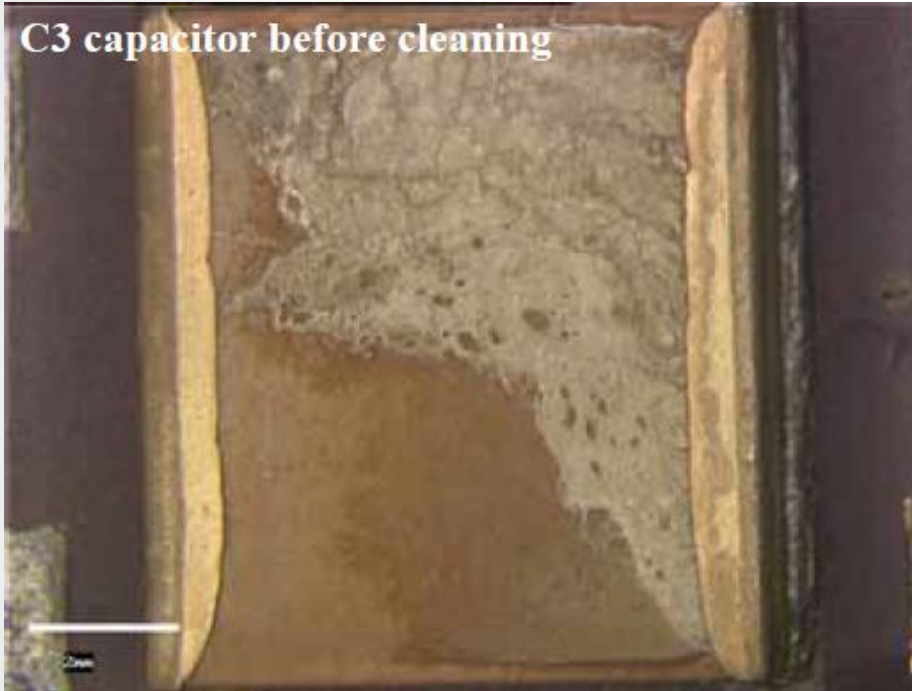
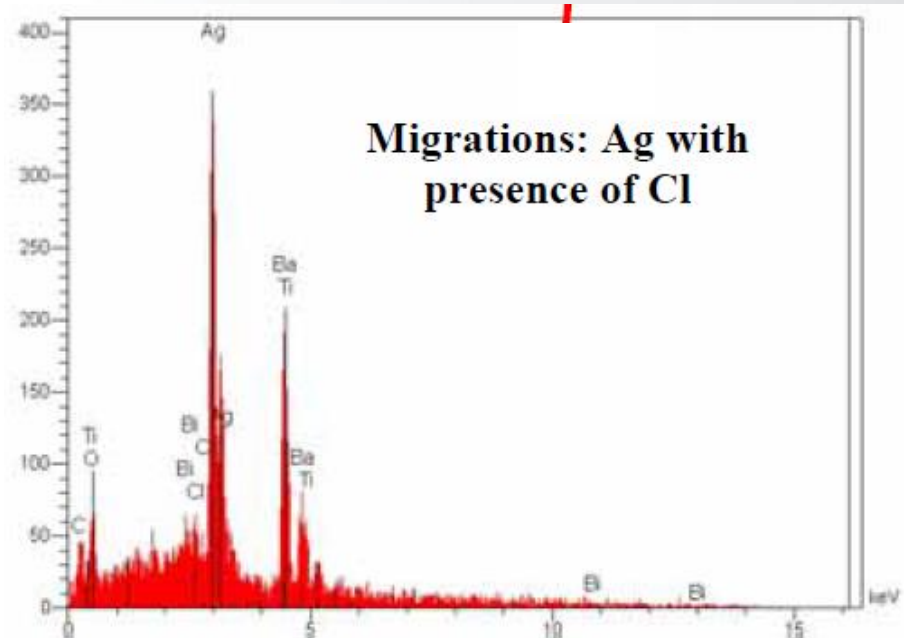
Ceramic Capacitors Migration

C3 capacitor before cleaning

Failure occurred during Environmental tests:

Moisture and contaminant (Cl,..) leading to Silver dendritic growth

→ **Short circuit**

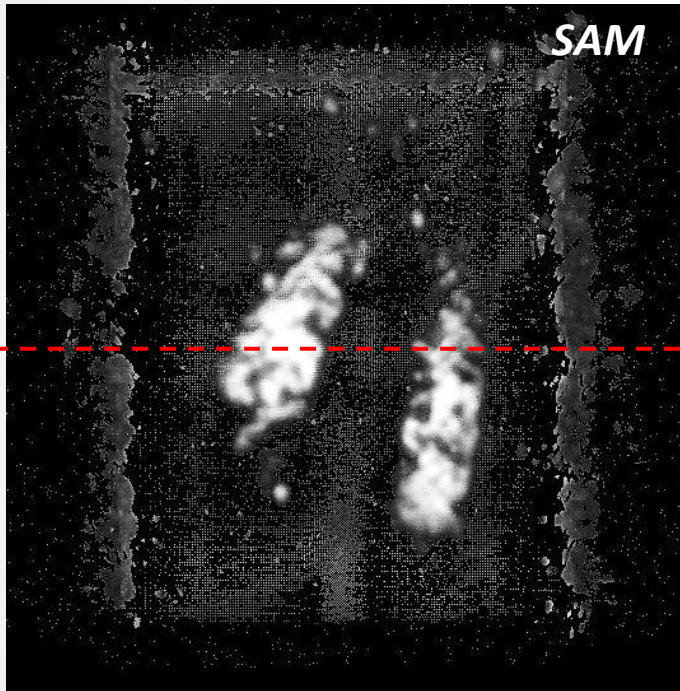
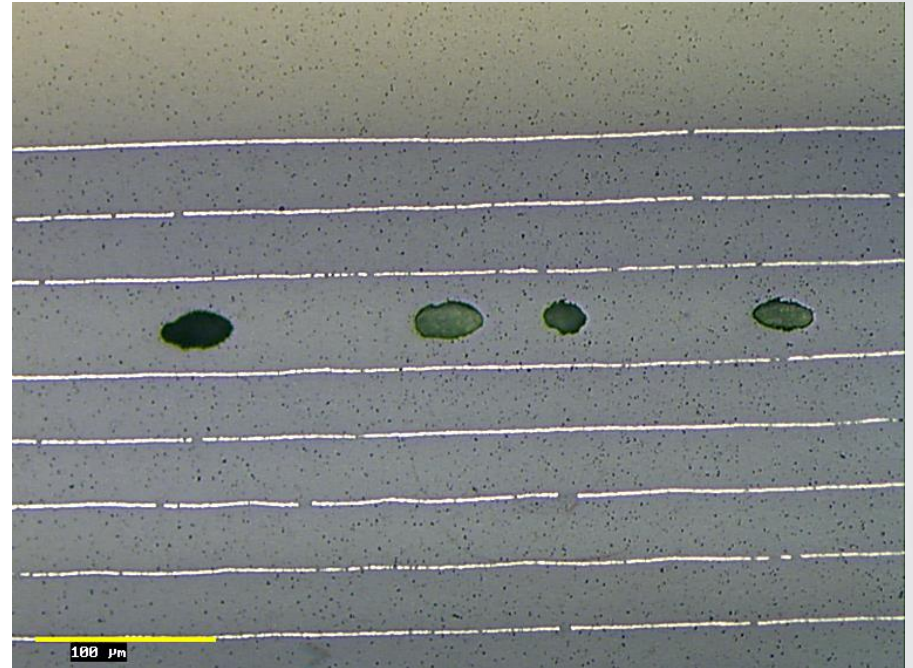
- Component quality
 - Ceramic preparation issue or organic/inorganic contamination
- Insulation reduction up to short circuit**

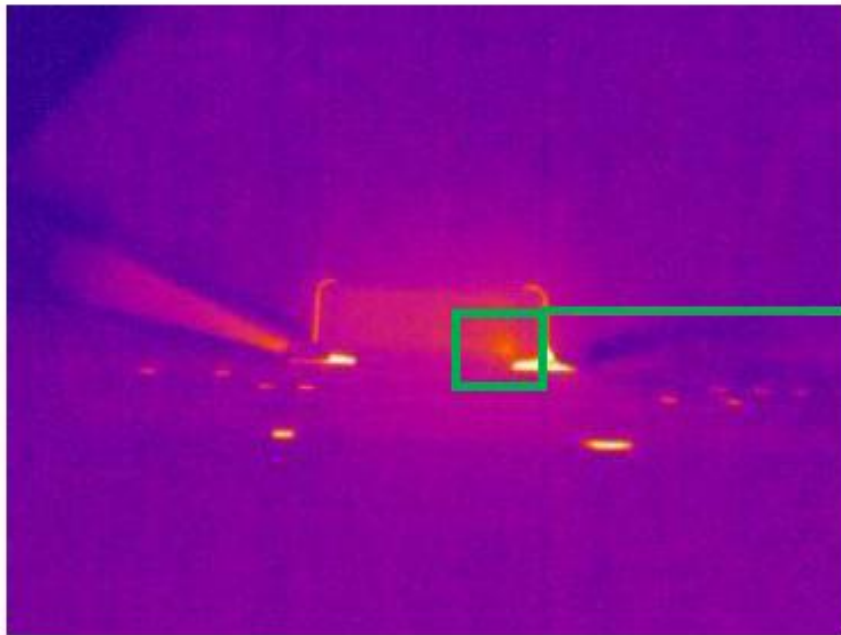
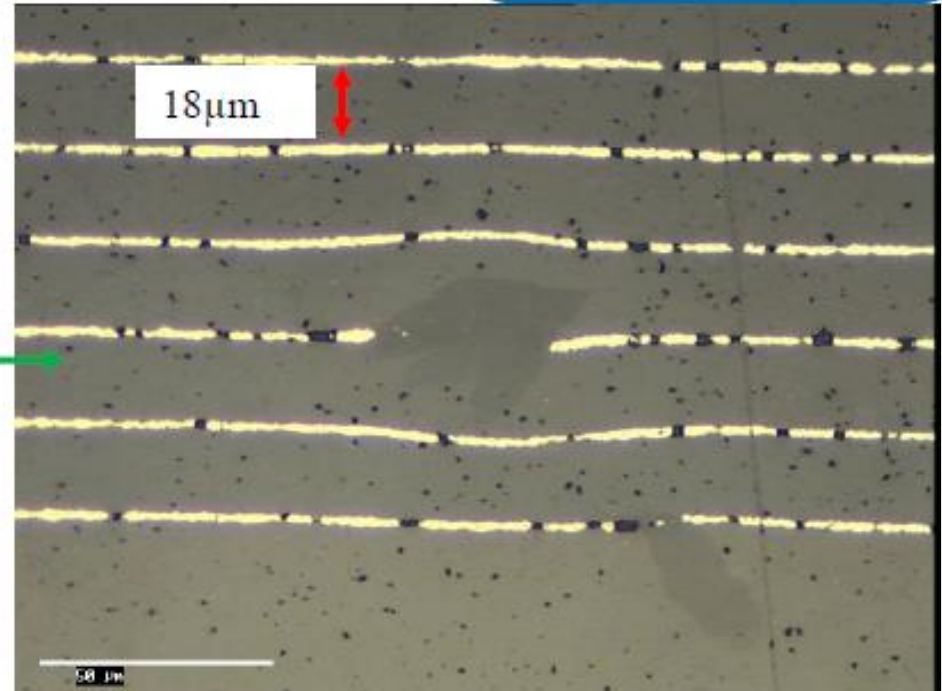
- Presence of a short circuit on a ceramic capacitor,
 - Infra red thermography confirmed the presence of the Short
 - Cross section showed the presence of specific phases
- **Conductive or not?**

O: 13,5%W
Ti: 50.0%W
Ba : 36.5%W

O: 11,7%W
Ti: 29.4%W
Ba: 59.9%W

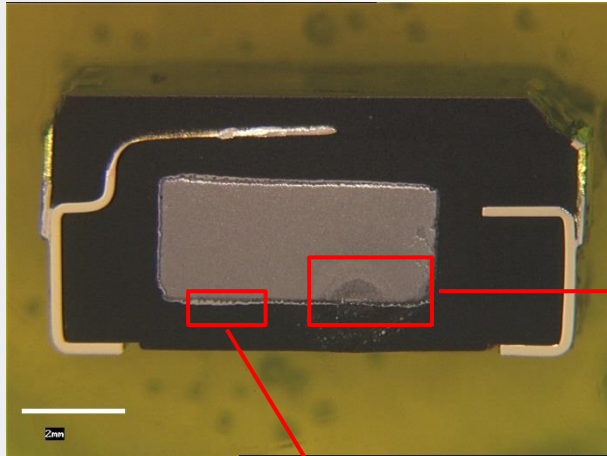
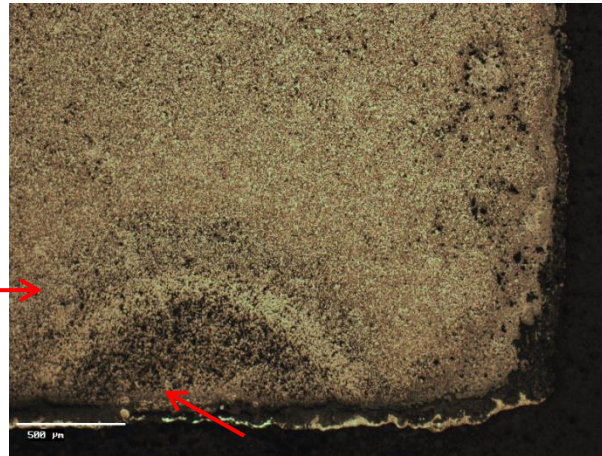
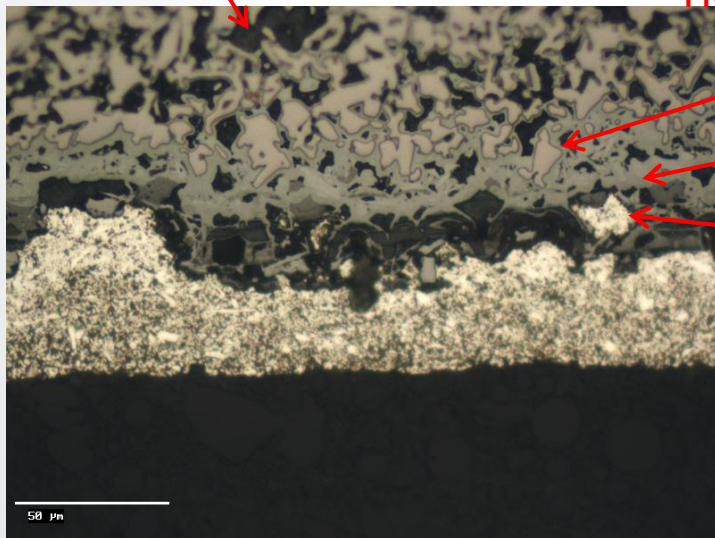
Tantalum Capacitor MnO₂ deposition

- Component quality
- MnO₂ layer thin and inhomogeneous
- Ag penetration

→ Local ESR reduced
→ Overheating
until short circuit

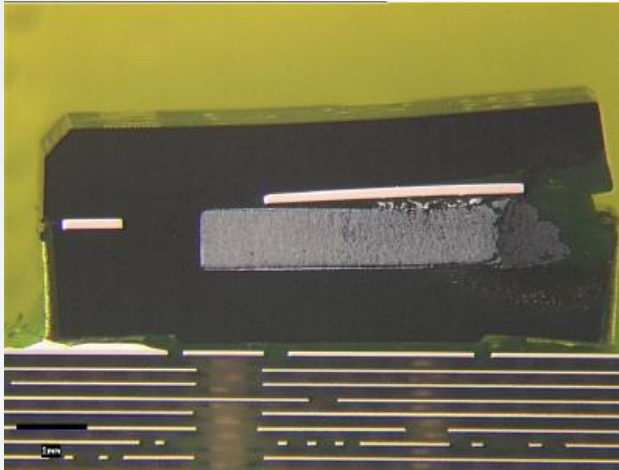
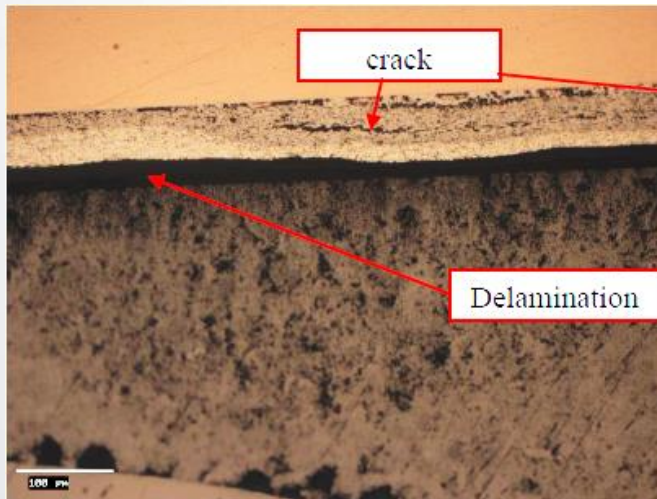
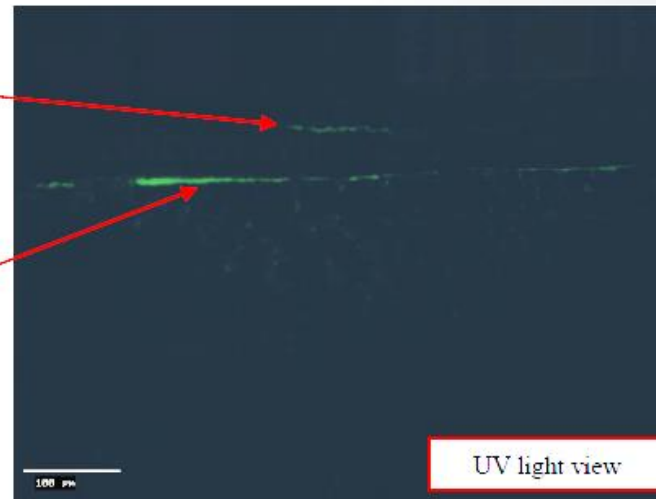
Tantalum Capacitors Delamination

Delamination due to component quality or assembly process
→ ESR increase up to thermal runaway

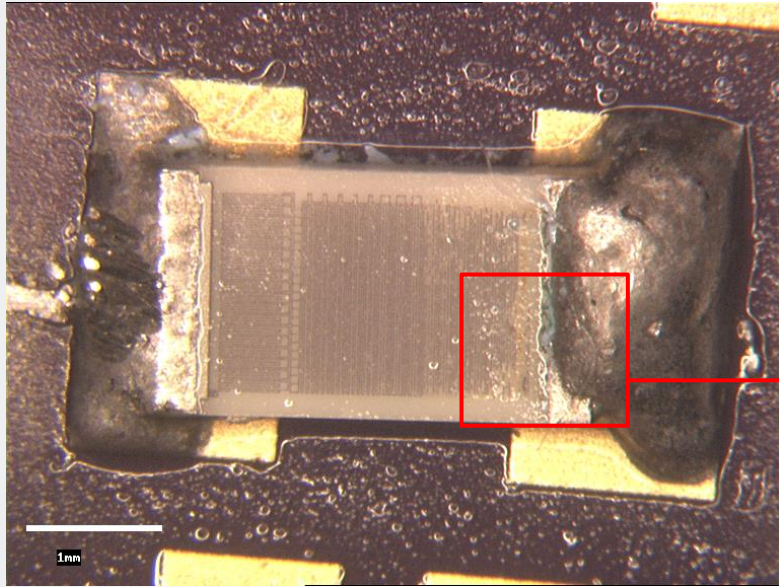
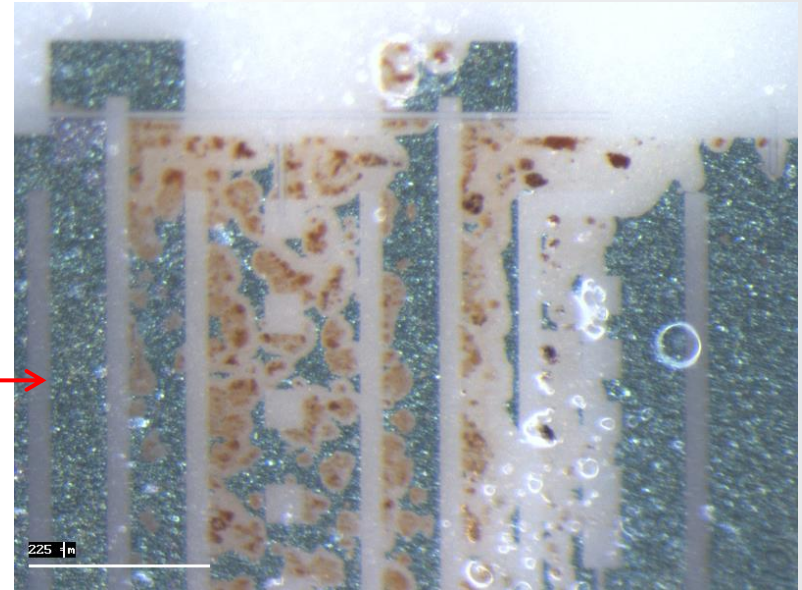
SMT Resistors (Thin film) Corrosion

Oxidation of the resistive layer in presence of humidity
→ **Resistance increases up to open circuit**

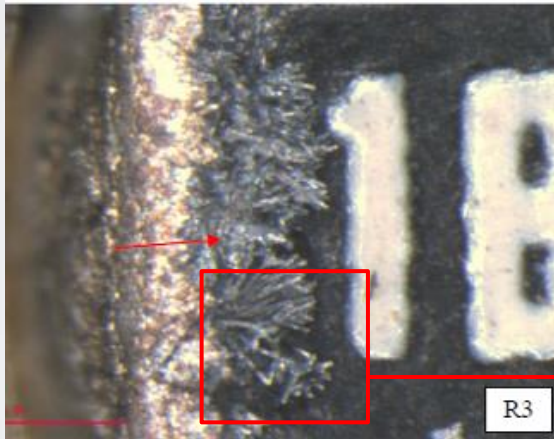
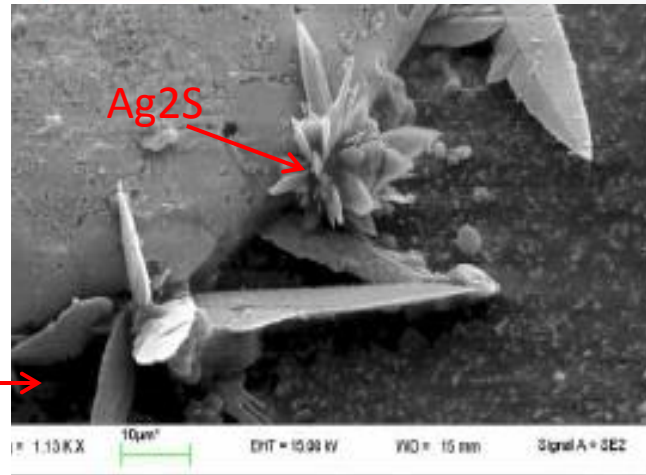
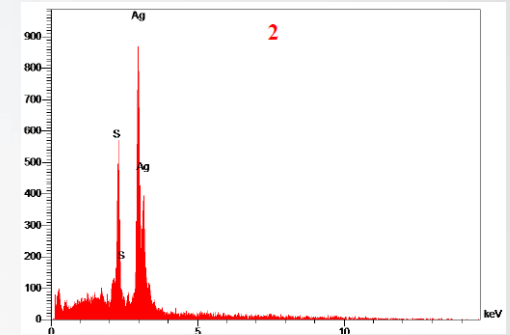
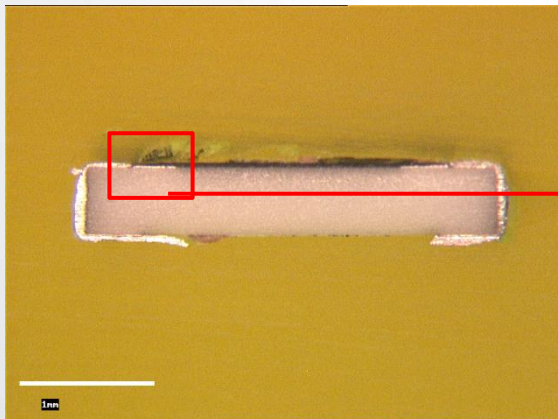
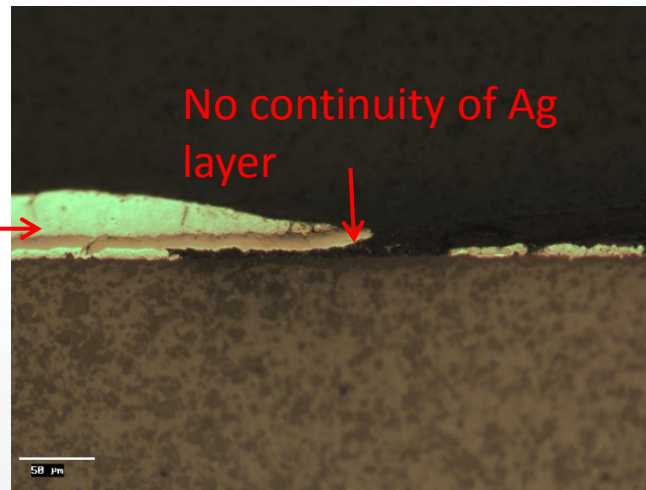
SMT Resistors (Thick film) Corrosion (sulfuration)

Environment:
Sulfur attack of silver
occurs at the
interface of the glass
passivation layer and
the resistor
termination

→ **Open circuit**
