Failure Analysis after in orbit anomaly on COMEPA bimetallic thermostat TH47

5th Space Passive Component Days (SPCD), International Symposium

15-18 October 2024

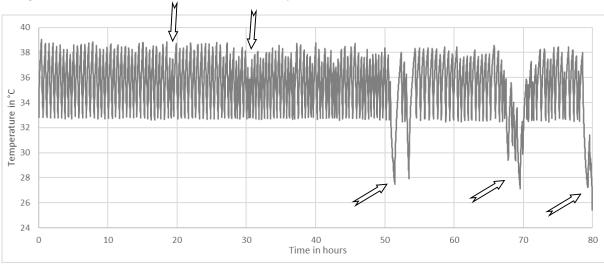
Figure 2: Partial Section of Telemetry data of heater temperature controlled by Thermostat TH47

The first few hundreds of cycles of the thermostat were nominal. Out of no apparent reason nor possible external factors however, the temperature oscillating profile started showing anomalous drops in the upper temperature as it can be seen on Figure 2 at around 20 and 30 hours of shown telemetry timeline.

The drop in temperature occurred stochastically and initially affecting only the functioning temperature (temperature at which the switch opens). Few cycles later, the restoring temperature started to be affected as well, as it can be seen from hour 50 onward. The temperature drop became so significant that the specific subsystem could not be operated reliably anymore and the switch to a redundant unit was deemed necessary.

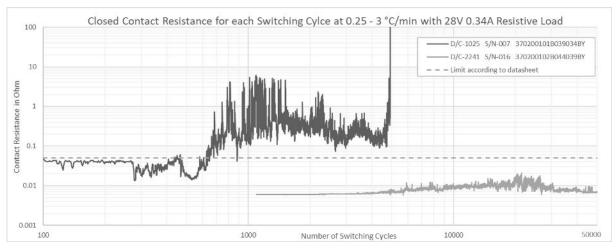
Figure 4: Contact Resistance Increase over Number of Switching Cycles

The TH47 manufacturer datasheet [3] specifies a limit of $50m\Omega$ for the contact resistance of closed contacts. The data plot in Figure 4, shows the calculated average closed contact resistance of the tested device up to 50 000 cycles. The tested thermostat S/N-007 started exceeding this value after about 400 cycles. The contact resistance showed a slight recovery before increasing significantly after 600cycles and showing a permanent open contact after approximately 5000 cycles, well below the 100 000 cycles expected lifetime for this thermostat, according to the relevant datasheet [3].

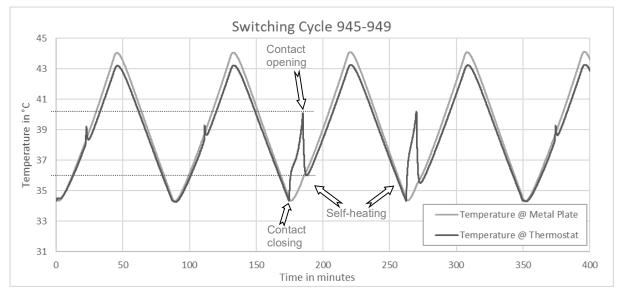
Figure 5: Self-Heating local Temperature increase on Thermostat

With the increase of closed contact resistance, the dissipated power at the contact increases following the well-known Joule heating relation $P=I^2$ ·R. Before the wear-out, on thermostat S/N 007 a contact resistance of up to 6 Ω was measured during the thermocycling. This resistance values at 0.34A led up to 600mW power dissipated at the thermostat contacts. In the temperature plots of Figure 5, showing the measured temperature of the supporting metal plate and the body temperature of the thermostat s/n 7, the effect of this 600mW power dissipated at contact level, caused the increase up to 4 Kelvin of the thermostat body with respect to the metal plate temperature, independently heated. This, so called self-heating effect, by reaching the bimetallic disc inside the thermostat, disrupt its nominal behaviour, leading to an opening of the contact well before the functioning temperature of 39°C is reached on the metal plate. The central cycles shown in Figure 5 for example, show the thermostat switching on at about 34°C and soon after, its body temperature increases sharply due to the joule heating at the internal contacts. The body temperature reached about 40°C while the plate temperature was still at about 36°C. With 40°C body temperature, the thermostat switched off and no more joule heating was produced at the contact, therefore the body temperature could quickly equalise to the plate temperature at 36°C.

The on-ground observed behaviour in Figure 5, mirrors the telemetry data in Figure 2 where first the functioning temperature starts to fluctuate before the restoring temperature drops as well.

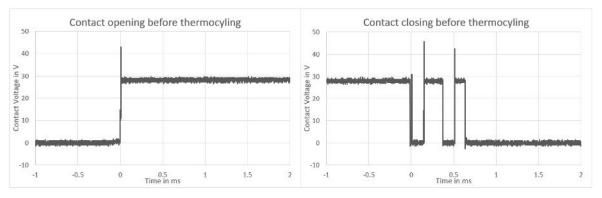
Figure 6: Switching Voltage Oscilloscope Plot at the beginning of Thermocycling

Figure 6 shows the voltage curves during the opening of the contact (on the left) and closing of the contact (on the right) switching's of the thermostat. The shown plots were recorded at the very beginning of the thermocycling, with no significant degradation of the contact yet observed. At the contact opening the voltage transferred very sharp from 0 volt to 28 volt. The small overshoot visible, is due to parasitic inductances in the loop. At the contact closing event, similar sharp transitions, with a significant bouncing's of the contact, can be seen. This bouncing back effect happens two times in total and can be considered normal for this kind of thermomechanical switches.

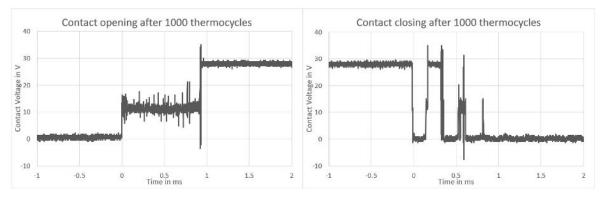
Figure 7: Switching Voltage Oscilloscope Plot after 1000 Thermocycles

Similar curves, taken after a significant amount of thermocycles, are shown in Figure 7. The voltage change from 0V to 28V at the contact opening, is not sharp anymore. Instead, the voltage sets to an intermediate potential level in the range of about 12V, showing random noise behaviour. This can be considered an indicator of electrical arcing between the switching contacts. This arcing event lasts over a duration of about 1ms. At the contact closing, similar arcing evidence can be observed with shorter duration.

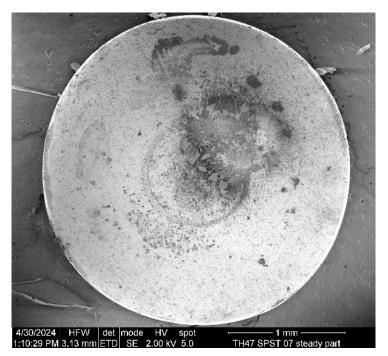
Figure 9: Scanning Electron Microscope Image of the contact surface

A more detailed investigation on the contact surface was performed to determine the nature of the contamination. Figure 9 shows a scanning electron microscope image of the bottom contact in Figure 8. Evidence of solid material deposited around the spot where the two contacts touch each other it is clearly visible. Due to the distribution and the morphology of the residual fragments, it is likely that the electrical arcing played a significant role in the formation and deposition of the foreign material at the contact interfaces.

Energy Dispersive X-Ray Analysis (EDX) was performed to investigate the elemental composition of the contaminants. The main elements detected were: Silicon, Oxygen, and Carbon. Worth to remember is that hydrogen cannot be detected via EDX analysis but, most likely, is still one of the elements in the chemical composition of the contaminants.

Based on all the measurements and analysis mentioned in the chapters above, the root cause of the in-orbit anomaly and the on-ground reproduced failure, is most likely the internal contamination of contacts by silicon compounds present inside the thermostat. In literature [4][5][6] the presence of silicon in close proximity to electrical contacts has been reported to cause the degradation of the contact resistance up to persistent opens. With the contact operations and arcing's, silicon compounds contaminating the contact area, break down [6] forming an insulating SiO₂ film [4]. The mechanical action of the contacts on this insulating film may disrupt its integrity, restoring the electrical contact to a certain extent. However, the stochastic nature of such "cleaning action" and the cumulation of non-conductive debris at the contact interface, eventually leads to a permanent open-circuit condition. Several factors play a role in the degradation of the contact resistance such as the voltage across the contacts, this should be high enough to create an arc but still with a current below a certain level so that the arc is not strong enough to clean the contact surface from contaminations; other significant factors could be: the force exerted on the insulating film during the mechanical switch and last but not least the amount of contaminant material in the proximity of the contacts.
