Keynote II. Quality Challenges and Risk Mitigation for Passive Components in Harsh Environments

ABSTRACT

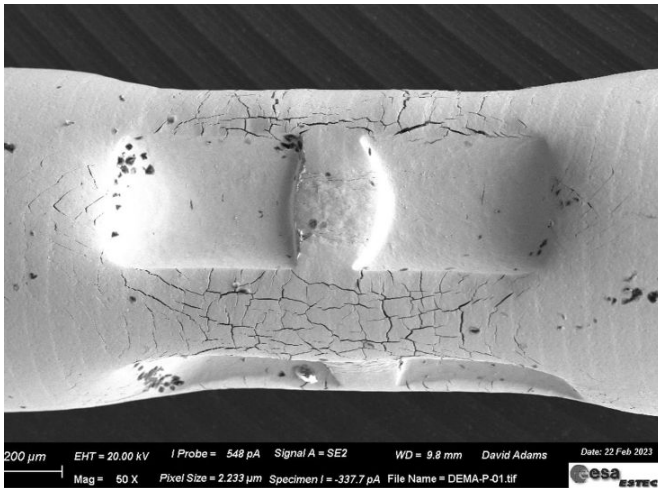
Figure 2 C/N 340100508B Cracks in crimping area (Credits: ESA)

Visual inspection and Microsection analysis confirmed the presence of cracks and areas where the nickel underlayer detached from the base material.

The **cause** of those cracks in the gold and nickel are due to a **Nickel plating with excessive Phosphorous content**. Nickel with high Phosphorous content is hard and not suitable for parts that are deformed. Therefore, there is a major action to be taken to the manufacturer in order to modify the plating parameters. The phosphorous content of the nickel has been measured around 12.5%, which is indeed *is compliant* with applicable specifications.

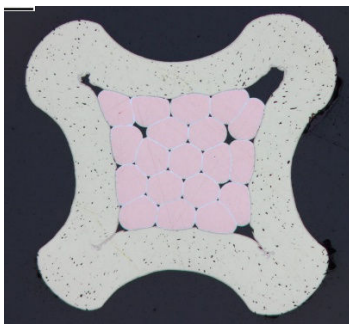
Figure 3 Cross section in crimping area (Credits: ESA)

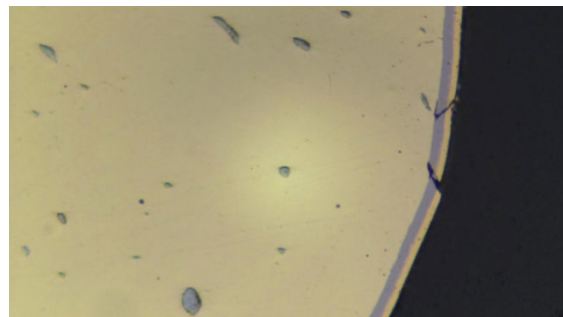
Figure 4 High magnification view of the cross section where the cracks are evident and going through underlayer

SEM imaging revealed excessive phosphorous content (~12.5%) in the nickel layer, making it too hard and unsuitable for deformed or crimped contacts.

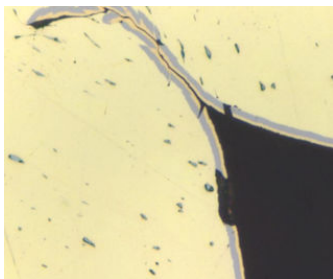
Figure 5 Detachment visible (Credits: ESA)

Cracks and plating detachment are considered as a major non compliances with the ECSS.

But in addition, there is contamination risk due to gold plating peeling.

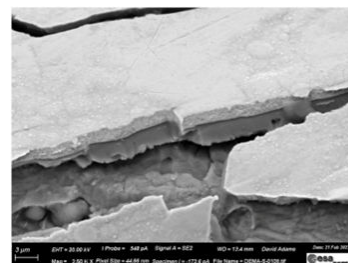
Figure 6 Detachment visible on the SEM (Credits: ESA)

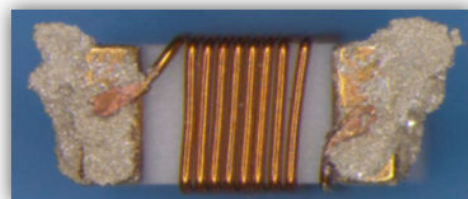
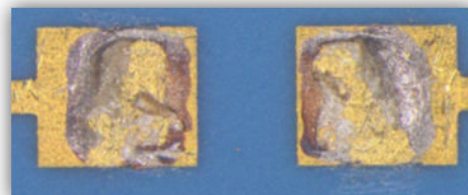
A comprehensive investigation was conducted, starting with die shear testing in accordance with MIL-STD-883, Method 2019.7. The test confirmed robust mechanical attachment (shear strength well above the limit 500 g), ruling out handling or bonding failures.

Figure 9 Views after Die Shear test. Silver Epoxy is observed

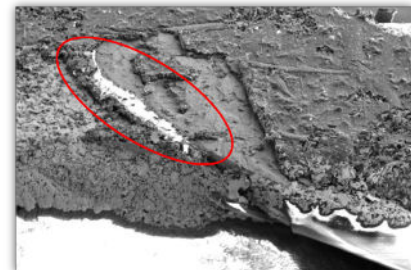
Further analysis via Scanning Electron Microscopy (SEM) revealed that the enamel coating of the coil wire was not fully removed and remained trapped within the joint. This residual enamel acted as a dielectric barrier, preventing a consistent electrical connection between the wire and the pad, especially under RF operation.

Figure 11 SEM picture of the coil contact / wire

The failure was rooted in a mismatch between component construction and the epoxy-based assembly process, not in a manufacturing defect.

The manufacturer confirmed that soldering with SnPb was the intended attachment method, and that epoxy-based processes may not reliably remove enamel from wire terminations. They recommended soldering or a full compatibility assessment prior to epoxy use.

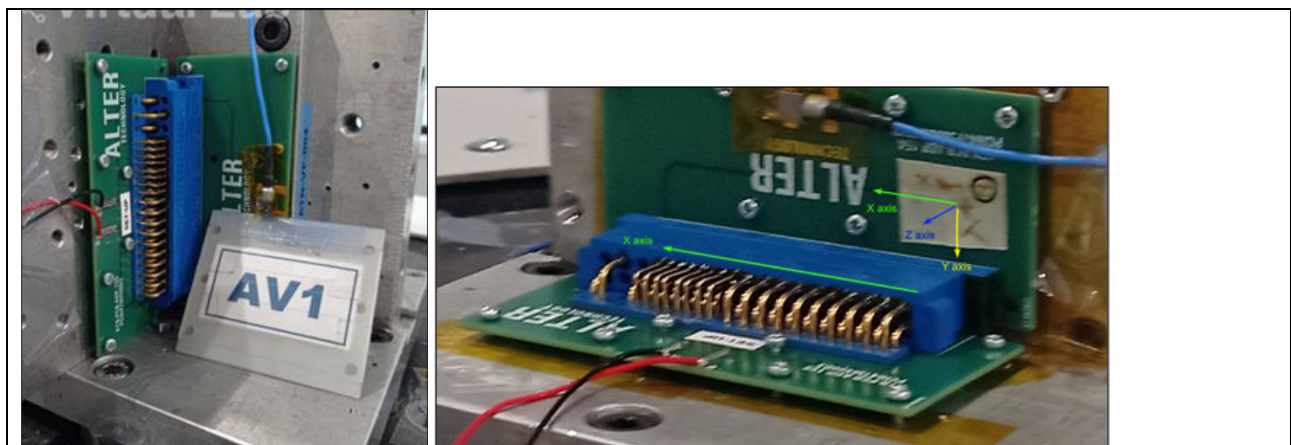
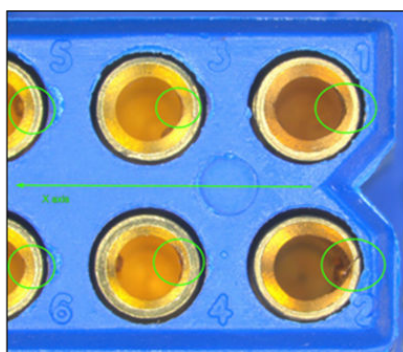
Shock tests were performed on three orthogonal axes using a closed-loop control system with tri-axial accelerometer feedback. During testing on the X-axis, one female connector sample developed a visible crack in one of its socket pins. No anomalies were observed in the remaining units or on the other axes.

Figure 15 External Visual Inspection (EVI) after Mechanical Shock test

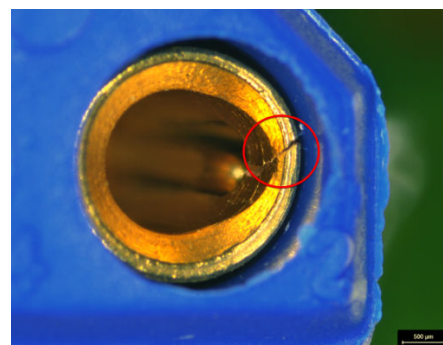
Figure 16 EVI after Mechanical Shock test: Female Connector with socket pin #2 cracked

The presence of only a single failure in a small sample group, combined with prior positive results on similar components, indicated the need to review the test fixture and mechanical interface conditions.

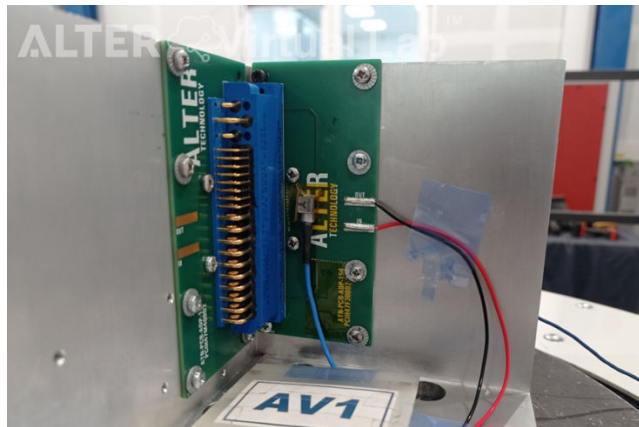
- All samples passed the test, and no cracking or mechanical deformation was observed.

Figure 17 Enhanced fixture and set up

- The base was modified to provide complete and stable support under shock loads.
3. Retesting
 - A new set of three connectors underwent the same shock test sequence using the improved setup.

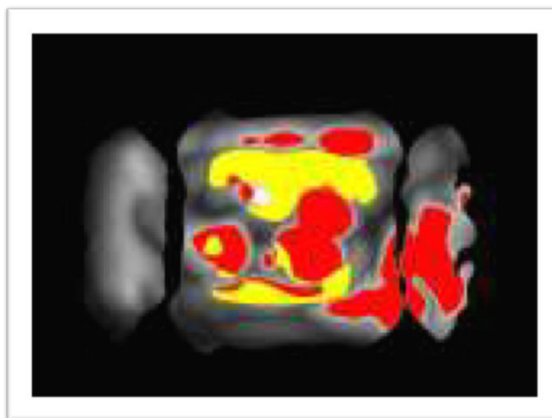
Scanning Acoustic Microscopy (SAM) was performed prior to cross-sectioning, revealing delamination-like features consistent with internal cracking.

Figure 26 Delaminations observed in SAM before cross section

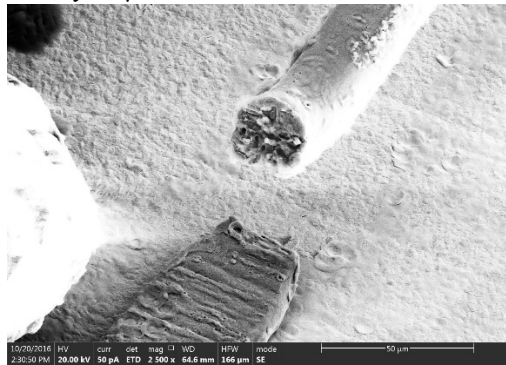
Figure 27 SEM view of broken wire causing open circuit

Failure analysis confirmed that the wire fracture occurred precisely at the junction between the winding and the lead frame. The wire was broken in such a way that contact could be temporarily restored by physically pressing the wire down with a micro-probe, demonstrating that the open circuit existed prior to decapsulation.

- **Mechanical Stress Sensitivity:** The ultra-fine wire (32 μm) was vulnerable to damage during welding and thermal excursions. Crimping force during the weld operation likely exceeded safe mechanical tolerances.
- **Incomplete Inspection Practice:** The visual inspection applied by the supplier was limited to top-side evaluation. Lateral crushing at the junction was not observable from that perspective and thus went undetected.
- **Process Induced Stress:** A degolding process, performed prior to reflow soldering, may have induced thermal shock, aggravating stress on the wire-lead connection.
- **Electrical Test Gaps:** During qualification at ESCC Class C level, certain electrical tests (e.g. Chart F3) were omitted, missing early signs of mechanical weakness.

- **Reinforcement of Qualification Flow**
Inclusion of intermediate electrical continuity tests is recommended, especially when using parts with fragile internal geometry.

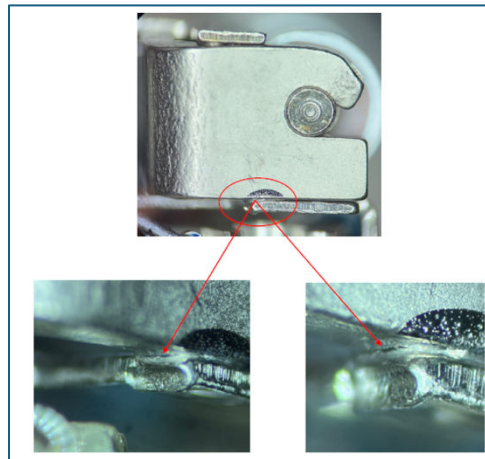
The non-compliance was classified as critical under ESCC Basic Specification No. 2043600, section 4.4.d, which explicitly disallows solder joints with visible cracks.

Figure 30 Cracks on solder joint in CSI precap

- **Incorrect electrode positioning** during header soldering
- **Excessive energy** applied in a concentrated area during the welding process
- Resulting in localized overheating and mechanical stress → *solder joint cracking*

The manufacturer proposed a rework process using **laser welding** to repair the cracks. To validate the robustness of this rework, a subset of relays underwent **Chart F4-like validation testing**, divided as follows:

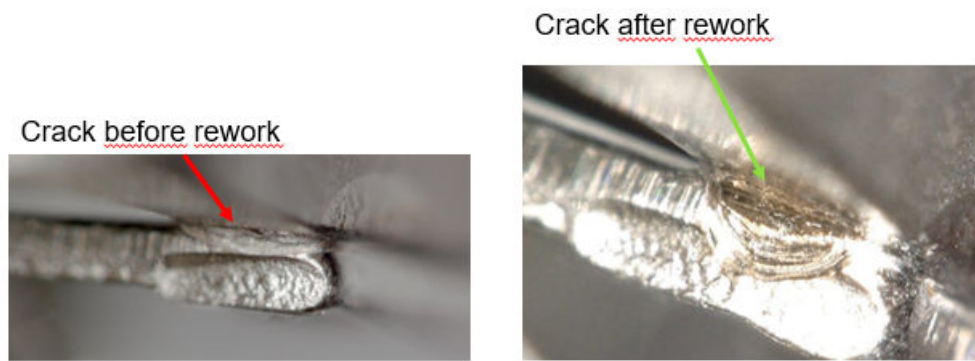
Figure 31 Example of manufacture's reworking of a crack

All tests were completed with satisfactory results. The rework method and final product quality were subsequently accepted by the involved agencies.
