# MICROELECTRONICS FAILURE ANALYSIS

# Failure Analysis of Capacitors and Inductors

**Javaid Qazi**

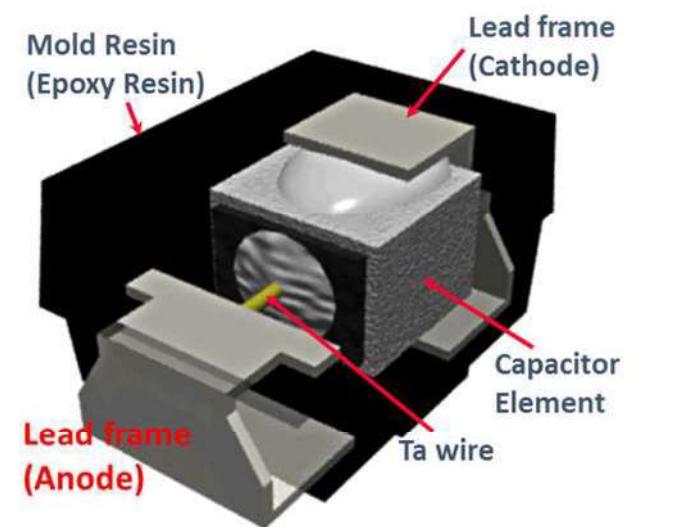
Figure 1. Typical Surface mount Ta-CAP construction [1].

Tantalum CAPS (Ta-CAPS) typically consist of a porous Ta anode (for high surface area) with a Ta wire attached to it. The dielectric, amorphous Ta<sub>2</sub>O<sub>5</sub>, typically a few tens of nm thick, is electrochemically grown on all surfaces of the porous Ta-anode [1]. Liquid electrolyte, MnO<sub>2</sub>, or conductive polymer are three commonly used counter electrodes, with the latter becoming the most commonly used. The positive connection is typically created by welding the Ta wire to a Lead Frame (LF). For solid state devices, connection between the counter electrode (polymer or MnO<sub>2</sub>) and the negative LF is made using conductive pastes and/or solders. Typically, the surface mount devices (SMD) are over molded (Fig. 1) [1]. Whereas, the wet and some through hole devices are typically hermetically sealed in a metallic can or a ceramic container. For wet Ta CAPS, an acid based liquid solution is used as the negative electrode. Other through hole devices are conformally coated or over-molded. Thanks to their benign failure mode and better electrical performance, conductive polymer Ta-CAPS are commonly used Ta-CAPS and rest of the section is mainly focused on this type, though most of what is discussed, is applicable to other Ta-CAPS as well.

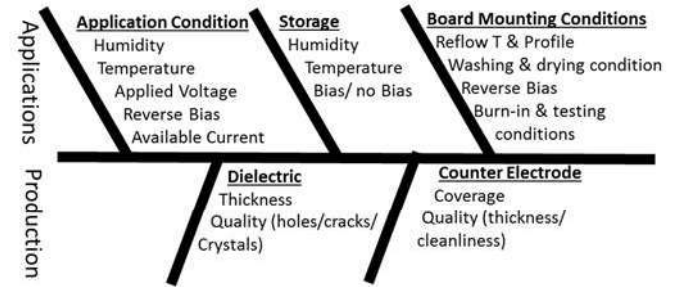
Figure 2. Common causes for the Ta CAPS’ high leakage or short failure condition [8].

Ta-CAPS can fail in high leakage/short, high ESR (Equivalent Series Resistance) or open/low capacitance mode, with high leakage/short being the most common mode. The high leakage or short failure could happen either as a result of compromised dielectric (Ta-oxide) thereby allowing the positive electrode (Ta metal) to come in direct contact with counter electrode (MnO<sub>2</sub>, Conductive Polymer or liquid electrolyte). This

typically will happen in or on the porous Ta anode. The other possibility is when a leakage path is created which by-passes the dielectric. This can be created either inside the molded device (bridging between positive and negative LFs) or the CAP is completely by-passed as a result of bridging between the negative and positive pads on the circuit board. In case of hermetically sealed Ta, the bridging could occur on the can lid, between the can (negative) and the positive wire. The common causes leading to high leakage or short failure by any of the above-mentioned mechanisms are grouped under production or application of the Ta-CAPS (Fig. 2) [8]. Most of the times failure occurs as a combination of different factors from these two groups.

Examination of the fault site might not always allow the determination of the cause of the failure. Different causes of failures (Fig. 2), lead to similar end-result: damaged dielectric, thermal interaction between Ta, dielectric and counter electrode, etc. The thermal and mechanical damage resulting from a failure can destroy evidence as to what caused the failure. This is where knowing the history and conditions the component was exposed to, be it board mounting, washing, storage, electrical and thermal exposures, etc., becomes very helpful in determining what failure mechanism/s might be at play. For example, most surface mount Ta-CAPS are not hermetically sealed. Extended exposure of these molded devices to harsh environments, such as high humidity and temperature, could lead to metal corrosion and ionic migration (e.g. Cu, Ag, Sn). This could create bridging on the positive end or compromise healing ability on the negative end. Significant work has been done to reduce/eliminate these ionic migrations [9]. Ionic migration might not look like a typical dendritic

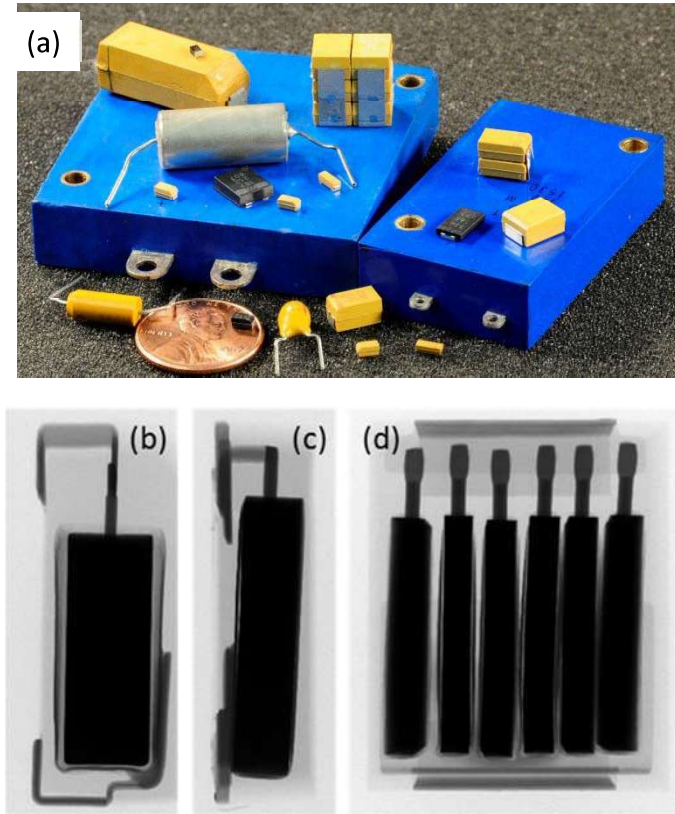
*Figure 3. Different types of Ta-CAPS: (a) Optical image showing external construction of variety of surface mount and through hole Ta-CAPS. X-ray images show internal constructions of (b) regular surface mount, (c) face down and (d) multi anode Ta-CAPS.*

Recent developments in X-ray technology allow better understanding of the internal construction of these Ta-CAPS. One such example is X-ray Computed Tomography (X-ray CT) which allows simultaneous virtual sectioning of a component from different directions. Fig. 4, for example, shows virtual sections of a polymer herm sealed Ta-CAP from different directions, showing Ta anode alignment in the can, as well as, presence of voids in the can-to-lid solder seal.

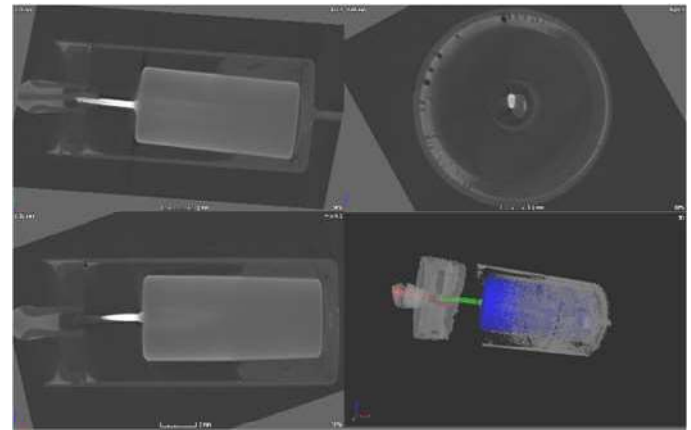
*Figure 4. X-ray CT analysis shows the virtual sectioning of a hermetically sealed Polymer Ta-CAP from three different directions.*

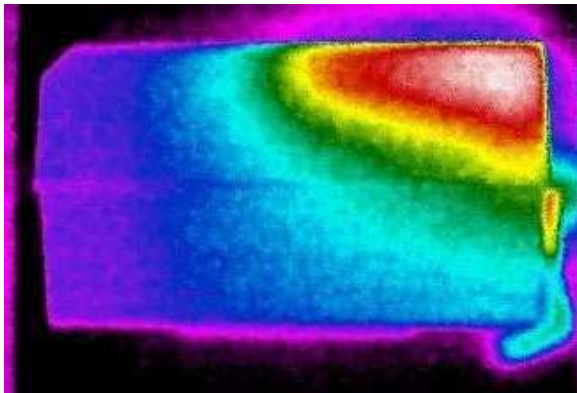
*Figure 5. Thermal Imaging of a Ta-CAP showing the hot spot indicative of fault site.*

CAP. In the absence of any external or internal anomalies detected by optical and X-ray examination, thermal imaging could be helpful in determining the location of failure site. The temperature gradient in a thermal image highlights source of heat. A hot-spot determined from thermal imaging is indicative of localized heating from a failure. Fig. 5 shows a bright red/white hot-spot, highlighting failure site near the negative end of the component. Thermal imaging along with X-ray and optical imaging, help in getting to the fault plane and hence allowing detailed analysis of the fault site and the surrounding area. This combination is especially helpful, for multiple anodes and stack Ta-CAPS, to determine how many and which anode(s) have high leakage or short condition. Caution should be exercised to limit the current and voltage applied to the Ta-CAP for thermal imaging, as it could cause additional damage. Voltage applied should not exceed the application or rated voltage, whichever is lower. The current can be limited via the power supply used or by adding a resistor in the circuit. Thermal imaging is a balancing act between limiting the voltage and current exposure and obtaining a thermal hot-spot.

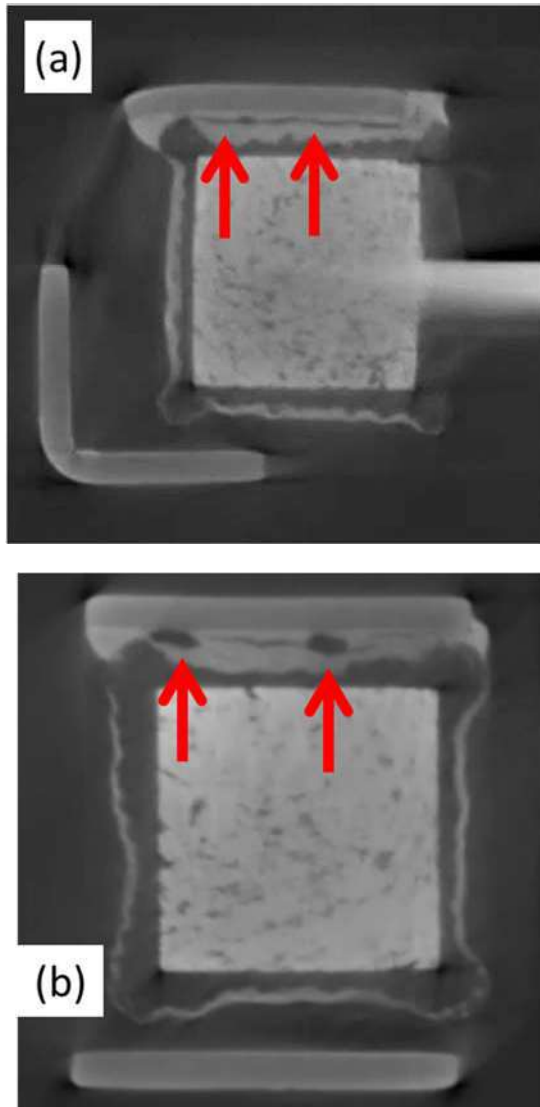
*Figure 7. X-ray CT images of a Ta-MnO<sub>2</sub> CAP show (a) side view near the center and (b) negative end view.*

Cutting the board around the CAP, with minimal damage is one of the options. This allows thorough internal construction examination with X-ray analysis and X-ray CT in some cases could be very helpful. De-soldering if necessary, should be done carefully to avoid over heating of the CAP. Fig. 7 shows an example of a negative connection issue which could lead to high ESR. X-ray CT images (Fig. 7) show virtual sectioning of the same CAP from two different directions. Significant delamination and voids (red arrows) between the silvered Ta-anode and the conductive adhesive used for attaching it to the negative LF can be seen in this case. Based on the X-ray analysis, the CAP could be prepared for detailed internal examination by sectioning it to a specific plane. Typically, for a single Ta anode CAP, sectioning it parallel to Ta wire to the center of it, exposes all the interfaces. For a CAP with a significantly higher ESR, micro-probing of the sectioned part

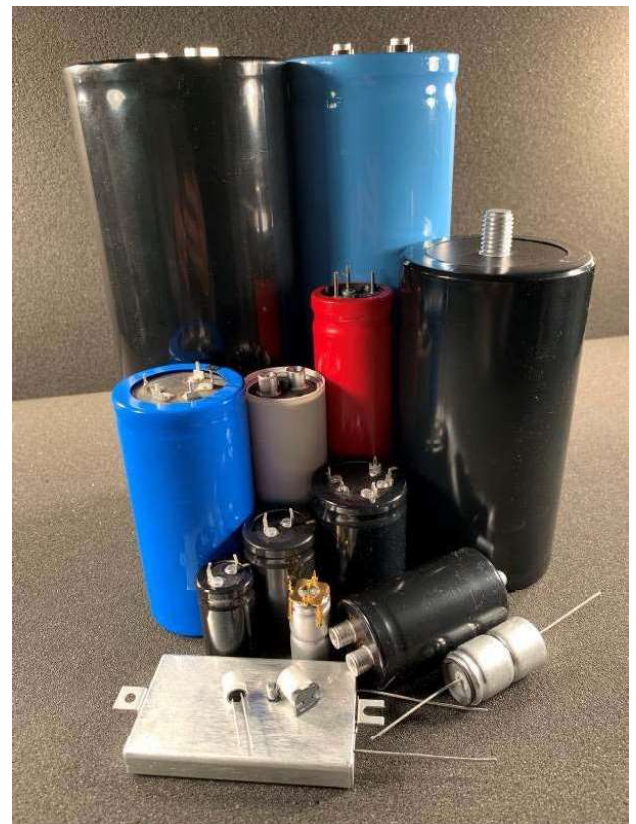
*Figure 8. Different shapes and sizes of Al-electrolytic CAPs.*

Al-electrolytic CAPS (Al-CAPS), based on their capacitance and rated voltage, are available in a wide range of shapes and sizes. Many of these are custom designed for certain applications, resulting in drastically different constructions, (Fig. 8). Al-CAPS can be broadly divided into two categories: axial and radial. Axial types typically have lead wires on both ends, though there are variants that use crowns for vertical mounting. Some are even surface mountable. Radial types are single ended, i.e., both terminals on same side. The most common ones have screw, snap in, or press-fit terminals. The failure analyst should determine the exact part number and refer to the manufacturer for detailed construction before performing a detailed FA.

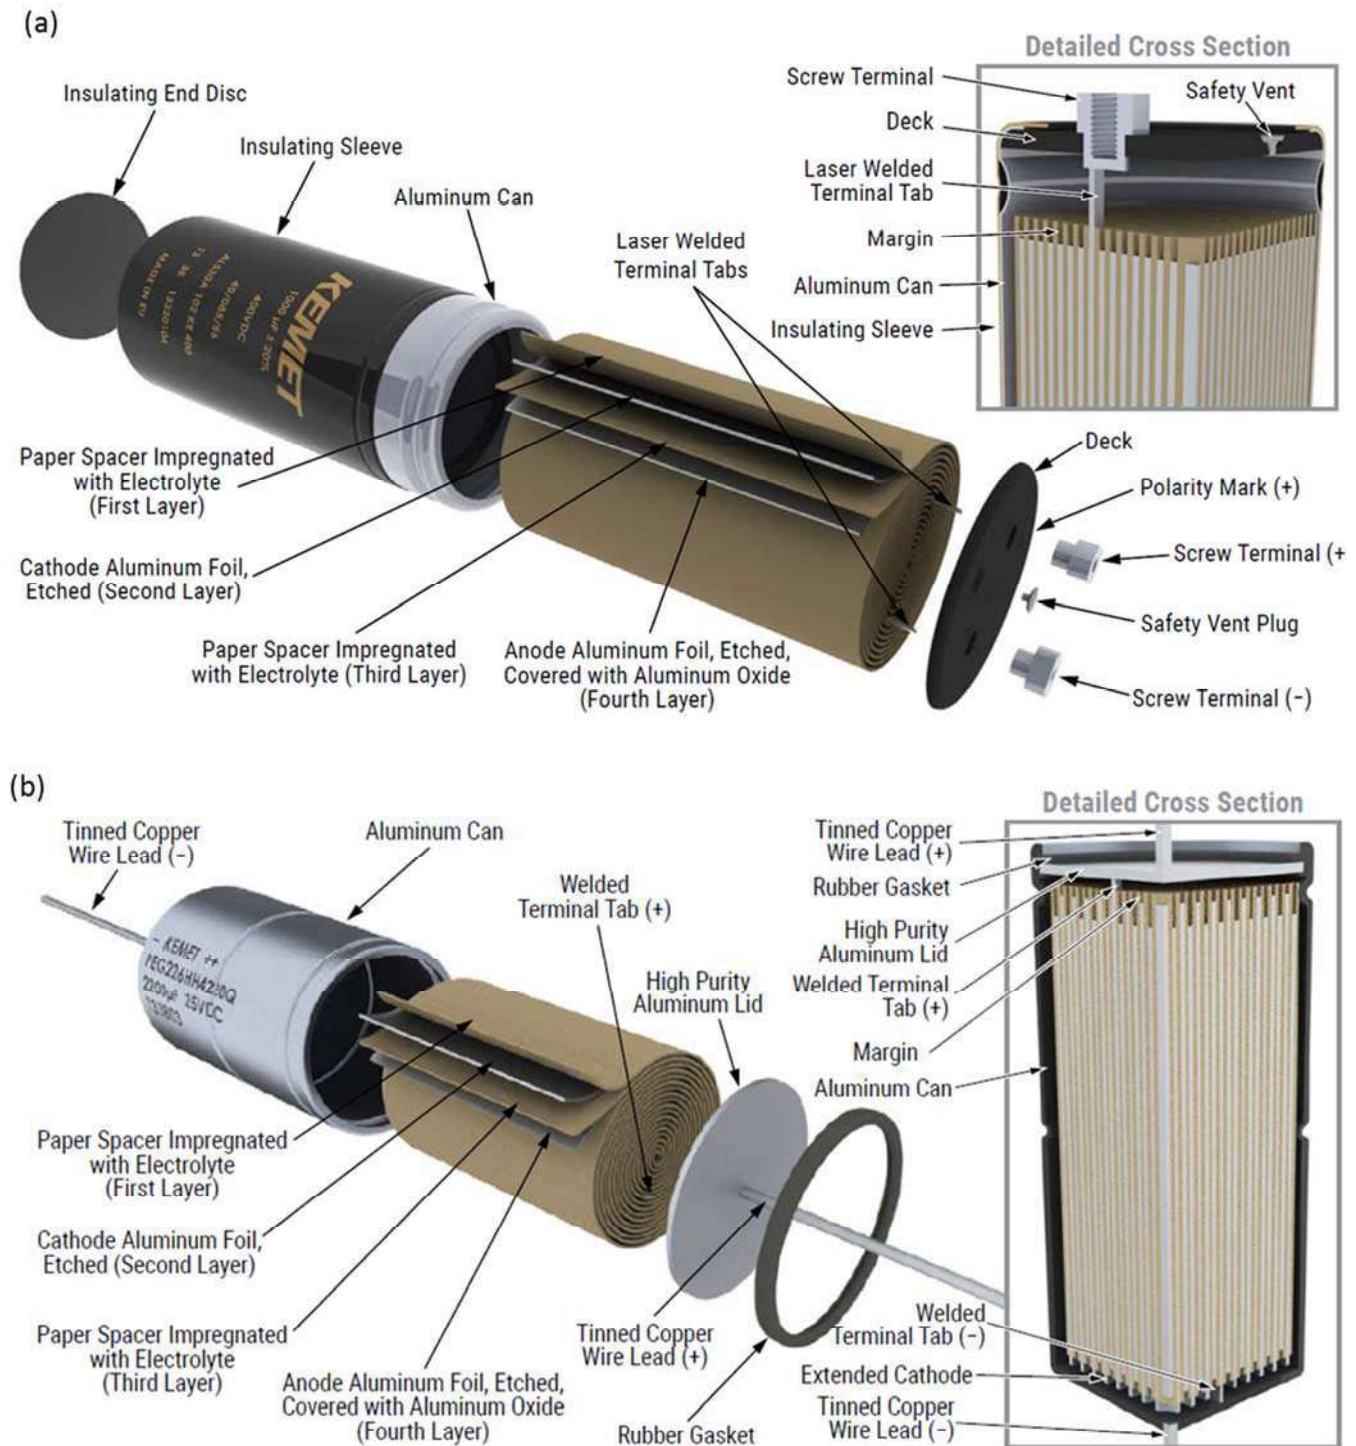
Figure 9. Constructions of (a) screw terminal and (b) through hole Al-electrolytic CAPS [1].

A typical Al-CAP consists of a cathode and an anode Al foils wound with a separator (typically paper) between them (referred to as the “wound element”). The wound element is impregnated with liquid electrolyte and/or a conductive polymer, which is then sealed in an Al-can, typically using an Al-lid or an insulative deck (depending on the construction) and a rubber seal. Al-tabs which are attached to both anode and cathode foils during the winding process, provide electrical

connection to the external terminals. Etched anode foil is used to gain significant surface area, hence higher capacitance in the same volume. The dielectric, aluminum oxide, is grown electro-chemically over the etched surface before assembling the wound element. Fig. 9 shows examples of the internal construction of two different types of Al-CAPS from a

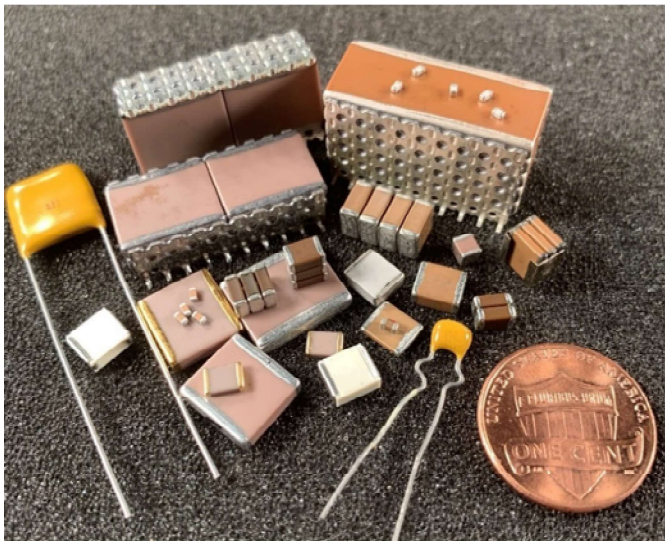
*Figure 12. Different sizes and construction of MLCCs.*

sintering) to attain bonding between different layers, end terminations are applied to make electrical connection with all the electrodes on each side. Two different constructions of MLCCs are shown in (Fig. 11): a regular design where every other electrode is connected to one terminal (Fig. 11a) and higher reliability design which has floating electrodes, not connected to either terminal to provide safer failure mode (Fig. 11b). Apart from internal construction differences, MLCCs are available in variety of different sizes and constructions (Fig. 12).

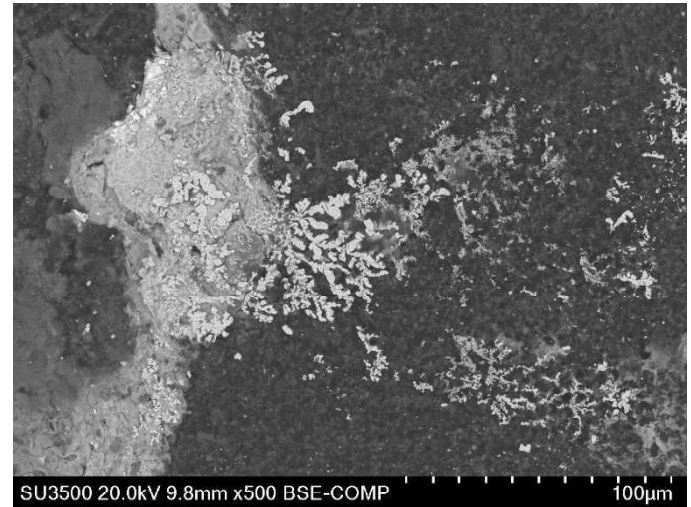
*Figure 13. SEM photomicrograph showing electromigration of Ag related to an MLCC Failure.*

The contamination leading to external bridging could come from a variety of sources including production process of MLCC, their storage and handling, board mounting and/or application. The presence of moisture and applied bias with surface contamination can create an ideal environment for electromigration of metals such as Sn, Ag or Cu, which are used in the construction of these MLCC as well as in the solders used for mounting and the printed circuit boards themselves. The scanning electron microscopy image in (Fig. 13) shows migration of Ag on the surface of a contaminated MLCC after high temperature and high humidity exposure with voltage applied. For an over molded MLCC, if electromigration is suspected, the epoxy should be removed carefully and both the epoxy and the MLCC surfaces should be examined for evidence of electromigration.

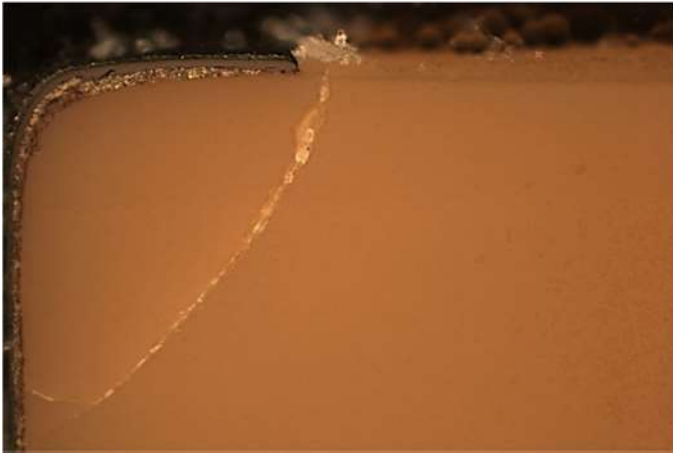
*Figure 14. Optical Image showing flex cracking in a cross sectioned MLCC.*

Another cause for low IR or short condition is cracks in the MLCC, especially flex cracking, which can result from stress on the rigid MLCC, during board mounting and/or board handling. Cracking can expose new surfaces of two or more opposing electrodes in close vicinity. Moisture or other conductive material can get to these exposed surfaces and can bridge the two opposing electrode causing low IR or short condition. The presence of moisture and bias could also result in electromigration in these cracks. The heat generated by a failure can further propagate the cracks, thus making it even worse. Flex cracking is one of the most common causes of failure and typically shows a crack from the edge of the termination at the board into the chip (Fig. 14). It is worth pointing out that chips are not always board mounted with the electrodes parallel to the board, especially for the near square chips (similar width and height), thus making detection of flex cracks somewhat tricky. Typically, the MLCC is sectioned from a side so that both the end terminations and the electrodes layers can be examined. Therefore, the failure analyst should document the CAP orientation on the board before performing any FA. Thorough external optical examination using regular and polarized light could help identify some of these cracks. "Vicinal illumination" can be especially helpful to aid in detection of very tightly spaced cracks and delamination between layers that may be obscured or undetectable with traditional lighting techniques [13].

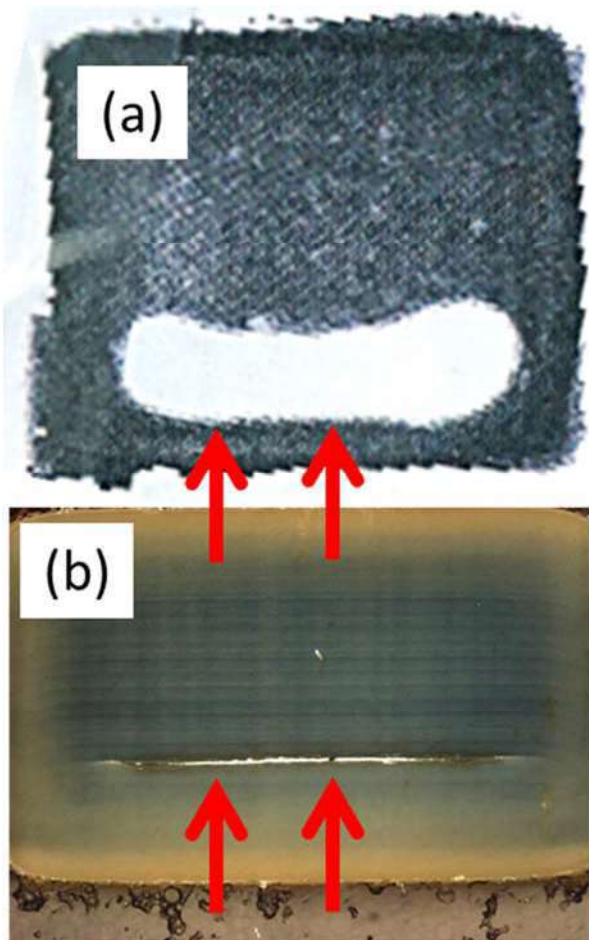
*Figure 15. Delamination in a MLCC detected by (a) C-SAM can be seen in the (b) cross sectioned view.*

Delamination/ parallel cracks between electrode and dielectric, typically a manufacturing fault, could grow with thermo-mechanical stress during the application. Consequently, these could jump across different electrode layers and cause cracking of the dielectric layer, thus exposing two opposing electrodes. Formation of a conductive path (as described above) between these opposing electrodes (moisture and/or ionic species) can lead to low IR or short condition. C-mode Scanning Acoustic Microscopy (C-SAM) allows the determination of such delamination. High reliability MLCCs are routinely scanned using C-SAM to inspect for any delamination. Once cracks or delaminations are detected, sectioning the part to the plane of interest could provide more insight into the root cause of the failure. For example, gross delamination detected by C-SAM in a MLCC, (Fig. 15a), helped guide in the sectioning process, which confirmed the delamination (Fig. 15b). In certain cases, thermal imaging could help determine the hot spot location in the CAP. Similar principles apply for thermal imaging as for Ta CAPS. The thermal image in (Fig. 16) shows the presence of a hot spot in a cross-sectioned MLCC, indicating the presence of sub-surface fault site in this case, as no external damage was detected.

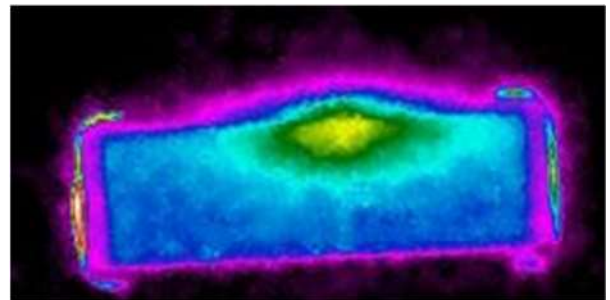
*Figure 16. Thermal imaging of a cross-sectioned MLCC shows thermal hot spot.*

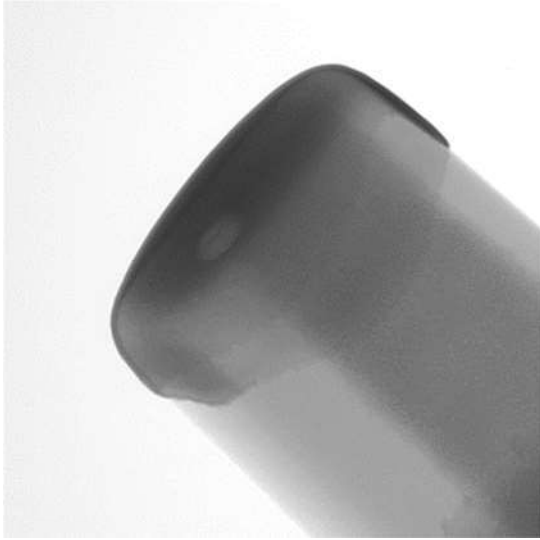
Figure 17. X-ray CT showing a void in the end termination of a MLCC [16].

Low or no capacitance can also result from disconnection of some or all electrodes to its termination respectively, thus making electrodes electrically isolated. X-ray CT in some cases

might reveal the disconnection between the electrodes and end termination (Fig. 17). After performing the electrical and external examination, cross sectioning of the MLCC to expose electrodes, will allow determination of which electrodes lack connection with the termination. If it is not readily visible by optical examination, then Cu back-plating (a technique to decorate the active electrodes), thermal imaging, or micro-probing can identify the culprit. Once the electrodes in question are identified, SEM could allow deeper understanding on the cause of delamination.

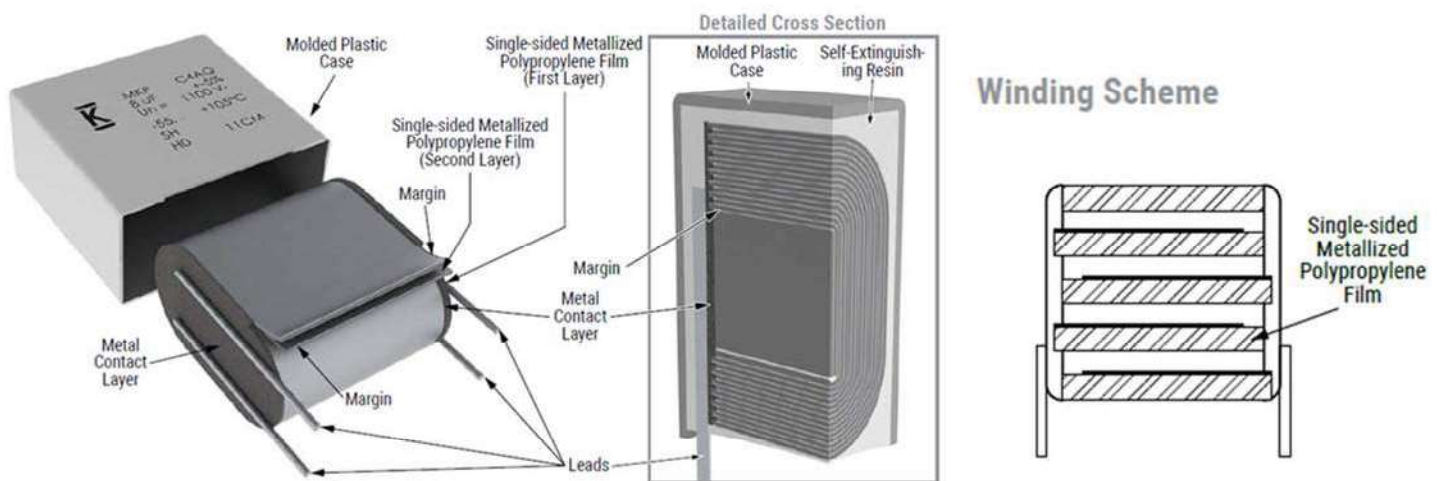
Figure 18. Typical internal construction of a film capacitor.

Just like MLCCs, film-CAPs are non-polar devices and have somewhat similar layered structure. In this case the dielectric layer, polymer film typically polypropylene (others include polystyrene, polycarbonate, etc.)  $2\text{--}20\text{ }\mu\text{m}$  thick, is metallized with a few nm thick Al and/or Zn layer (which acts as the electrodes). A small “margin” of the film is left unmetallized on one end. Hundreds or even thousands of these layers are stacked or wound together, with every other layer being displaced to one side (Fig. 18) and the margin being on the opposing end. End termination is then applied on each side, typically with the same metallization (Al or Zn) sprayed on it, followed by a solder layer, typically Sn. End termination makes the electrical connection to the thin metallization layer in each layer in the winding. The external surface of the end termination provides solderable region and it also provides physical support to the winding. Depending on the design, electrical terminals are attached on each end and the whole assembly is put in a case which is filled with an epoxy or poly urethane (PU) resin. In some cases, this step is skipped, and the capacitor is used in naked/unpotted construction. A number of these capacitors could be joined together before encasing these, to achieve desired electrical properties.

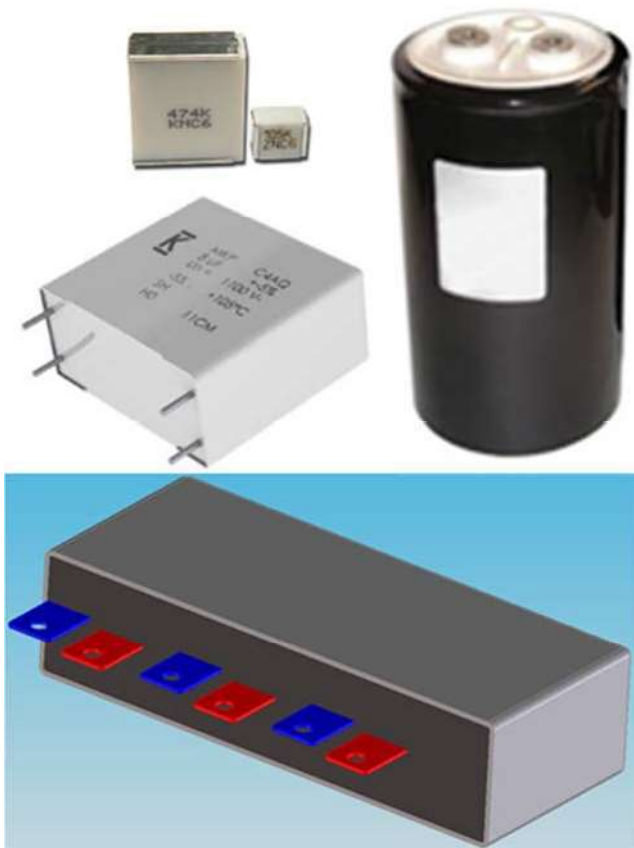
Figure 19. Different sizes and constructions of film capacitors.

Film CAPS are available in variety of constructions, sizes and designs (Fig. 19) for different applications. The failure analyst

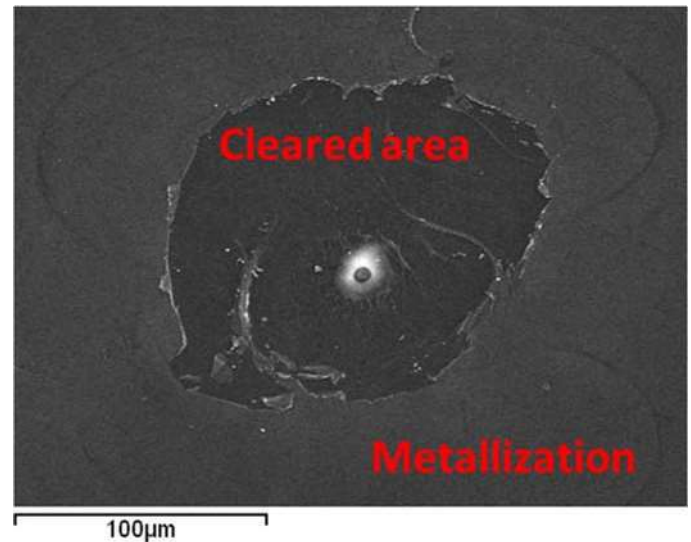
Figure 20. SEM image shows a pin hole in the middle, with a cleared area around it and a typical metallized surface in a de-processed film-capacitor.

catastrophic failure. If there is a dielectric breakdown, the energy released by the arcing (plasma discharge) at the breakdown site evaporates the thin metal layer in the surrounding areas of the fault site. This so-called “clearing phenomenon” isolates the fault site, thus restores low leakage current with a small capacitance drop (Fig. 20). In extreme cases “clearing” can cause excessive amount of effective area loss, resulting in significant capacitance loss. Biaxially oriented polypropylene has the best self-healing properties and, therefore is used as the dielectric in high energy applications.

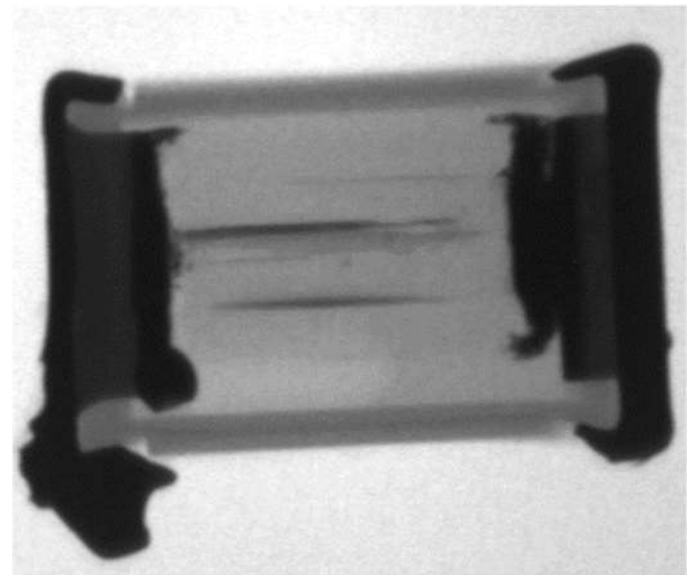
Figure 21. X-ray image showing internal bridging of a film-CAP.

heating in the CAP, or high temperature exposure especially during board mounting process. An extreme example of this type of failure detected by an X-ray (Fig. 21), revealed solder reflowed into the “film winding” thus bridging the opposite metallization layers resulting in a dead short.

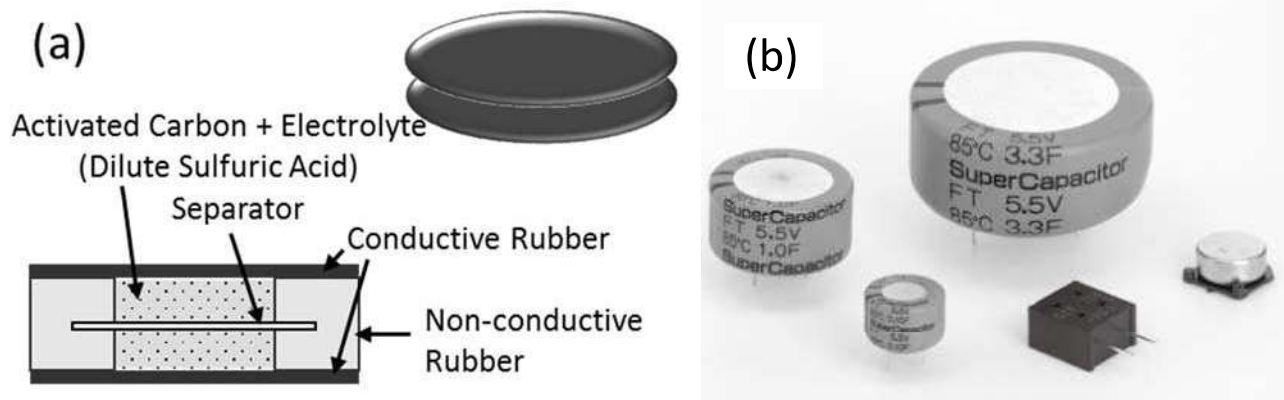
Figure 22. Super CAPS (a) base cell construction and (b) different shapes and sizes.

have much higher capacitance than the regular CAPS, with lower voltage limits. These CAPS bridge the gap between regular CAPS and batteries. Unlike regular CAPS, there is no dielectric in Super CAPS. Rather these consist of a conductive electrode and an electrolyte. Once voltage is applied the charge is stored electrostatically and/or electrochemically. Figure 22a shows basic base-cell of a super CAP, consisting of two opposing electrodes typically conductive rubbers, with a mixture of activated carbon and dilute sulfuric acid paste between two conductive rubber discs. An organic separator keeps the positive and negative ends isolated yet allows charge to travel across. Sealing material and curing of the rubbers seal the base cell. A desired number of these base cells are stacked on top of each other and terminals connected to obtain the desired product (Fig. 22b).

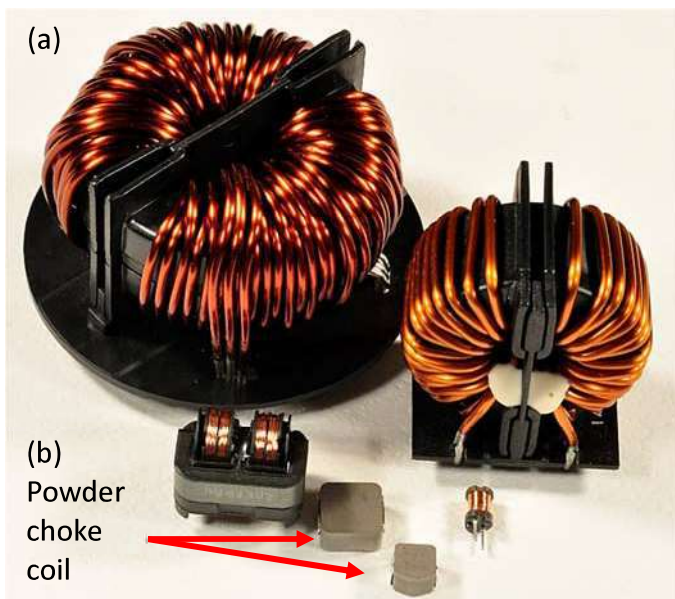
Figure 23. Different types of INDS (a) Common Mode Choke Coil and (b) Surface Mount (Powder Choke Coil).

metal alloys. Based on the construction, INDS can be divided into two common types, Common Mode Choke Coil and Surface Mount Powder Choke Coil, (Fig. 23), both are discussed in the following.

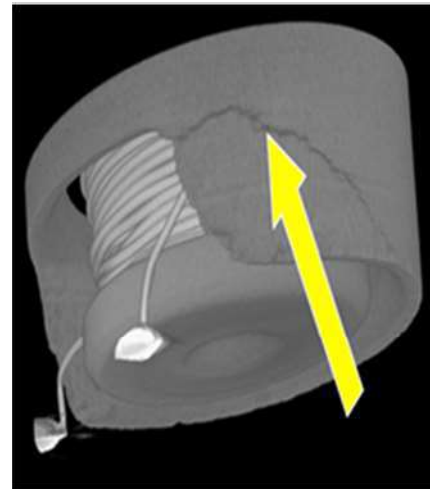
Figure 24. X-ray CT analysis shows a crack in the ferrite core.

CMCCs could fail open, short, or exhibit parametric losses. Shorting by insulation defect is the most common failure mode. Insulation coating of the wire could be damaged by mechanical stress, during winding, or the wire is over heated by excessive current (during application), and so on. Open mode failure may occur by excess current and/or a defect in terminal soldering. A damaged core, such as cracking, may cause parametric changes because its magnetic properties are changed. This is especially true for a ferrite-based core: the ferrite being brittle in nature, can easily be damaged by mechanical or thermal shock. In one such example, external examination of a low inductance failure did not show any anomalies. Internal construction examination utilizing X-ray CT (Fig. 24) revealed the existence of a crack in a ferrite core. Decrease in the core size could lower the inductance. The nature of the crack suggests that the core was damaged by mishandling.

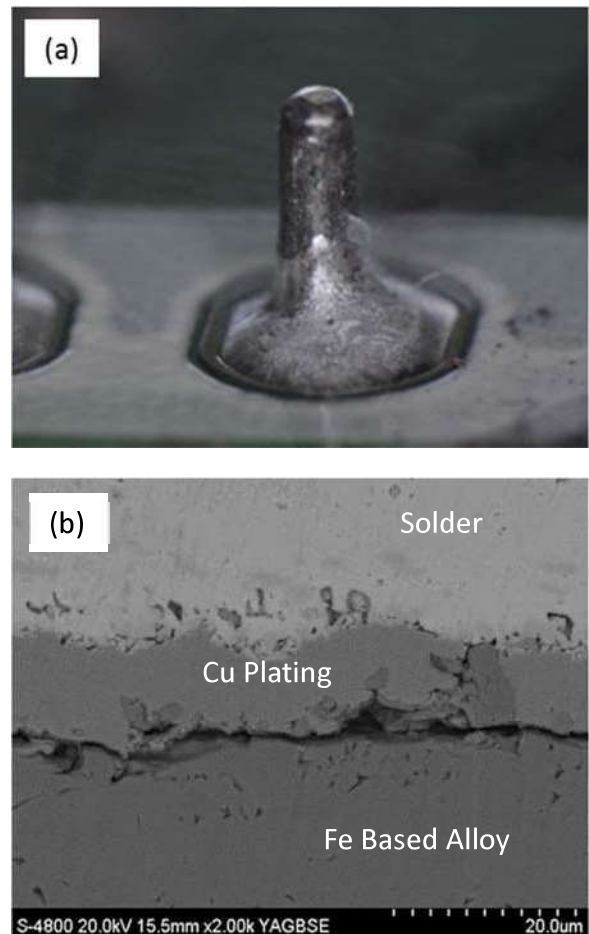
Figure 25. Open IND Failure (a) external as-is image and (b) SEM image showing delamination in a cross-sectioned view.

An open mode failure could occur by compromised lead connection. Fig. 25a shows a closeup of a terminal of an open IND after soldering operation. External examination did not reveal any apparent defect. The part was potted in an epoxy and cross-sectioned for an internal construction examination. SEM-EDX analysis of the terminal solder interface showed delamination between the terminal (Fe-based alloy) and copper plating (under plating between terminal and solder). These types of failures are typically attributed to an improper plating process.
