4.2. Reliability of E-Textile Conductive Paths and Passive Component Interfaces

Julie Hladikova, Martin Hirman, Jiri Navratil

Department of Materials and Technology, Faculty of Electrical Engineering, University of West Bohemia,
Pilsen, Czech Republic, jhladik@fel.zcu.cz

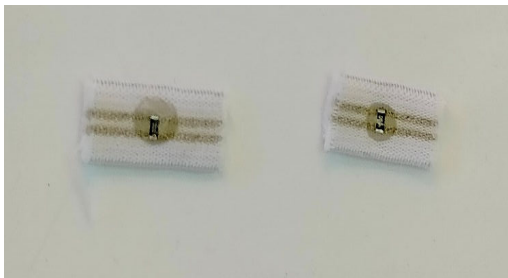
Figure 2 Samples with basic protection

1. No Protection – SMD resistors were mounted directly onto uninsulated ribbons using UV-curable adhesive, without any encapsulation (Fig. 1).
2. Basic Protection – Identical to the previous group, but with encapsulation of the component using UV-curable adhesive. This did not cover the ribbon's conductive paths but provided mechanical protection for the component (Fig. 2).
3. Additional Protection – Combined basic encapsulation with iron-on textile tape covering the conductive paths. Crimp contacts were applied to allow electrical measurement (Fig. 3).
4. Insulated Ribbon – Ribbons with polyurethane-insulated conductive paths were partially laser-stripped to expose the connection area. SMD resistors were mounted as before and encapsulated with basic protection. Crimps were added on both sides for measurement access (Fig. 4).

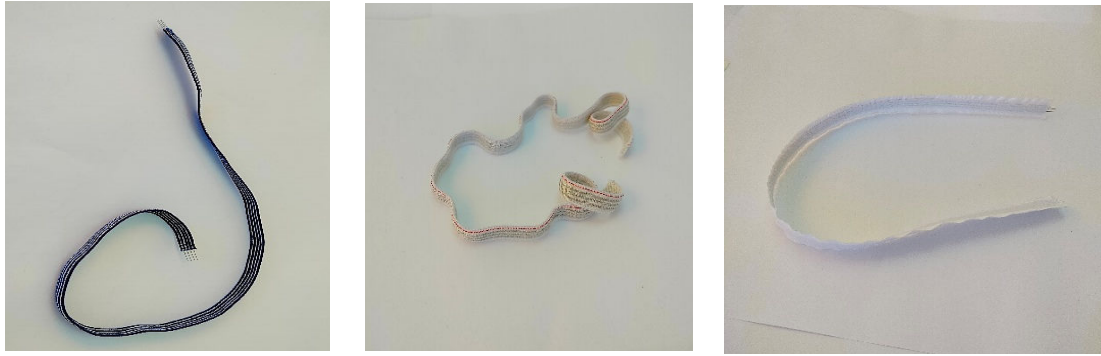
Figure 5 Samples of ribbons from left insulated, uninsulated, additional protection

- Uninsulated ribbon
- Uninsulated ribbon with iron-on tape (additional protection)
- Insulated ribbon

Samples with iron-on tape and insulated ribbon intended for resistance measurement were equipped with crimped contacts.

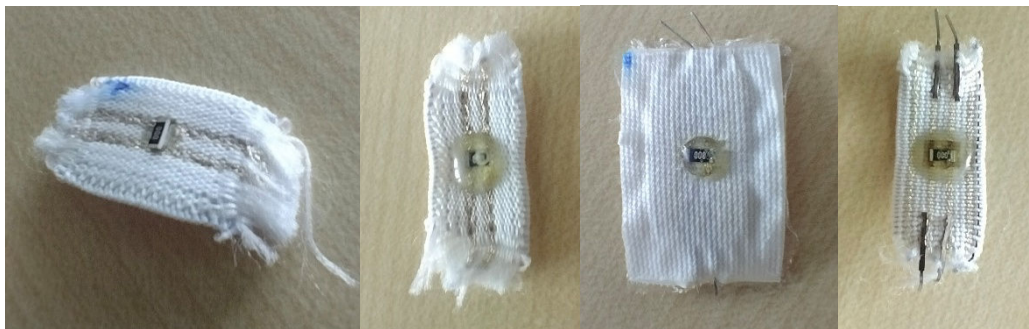
Figure 8 Samples after 30 washing (from left to right without protection, basic, additional protection, insulation)

These results suggest that the combination of proper encapsulation and controlled material layering is more effective than relying solely on insulation or extensive sealing. Basic UV protection appears to offer the best trade-off between simplicity and reliability in washable e-textile assemblies.

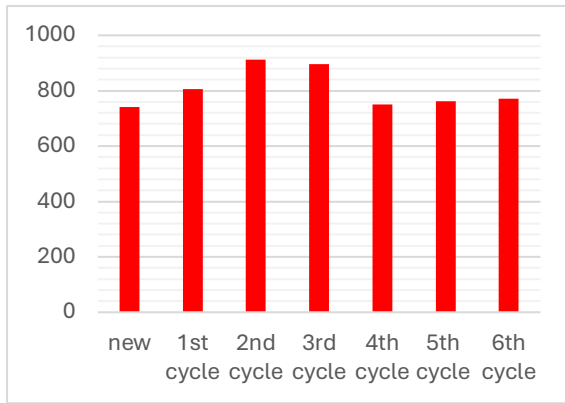
Figure 9 Graph of resistance after each cycle of uninsulated ribbon

The uninsulated ribbon demonstrates relatively stable resistance, suggesting minimal degradation and reasonably consistent electrical performance. The insulated ribbon, however, exhibits a marked and continuous rise in resistance. This pronounced increase likely results from degradation mechanisms such as trapped heat, oxidative effects, or delamination within the insulating material. The ribbon with additional protection starts at a slightly lower resistance and shows a gradual, monotonic increase by the final cycle. While this trend indicates the slow but steady rise suggests mild aging or interaction at protective interfaces over time. Added iron-on tape may have unintentionally allowed microleakage, trapping water and detergent underneath the layer, which then slowly deteriorated the conductive path.

Among the tested samples, the uninsulated ribbon shows the most stable resistance and thus the best electrical endurance under cycling. The ribbon with additional protection performs comparably well but with a detectable increasing trend, while the insulated ribbon exhibits the poorest stability, making it the least favourable for applications requiring long-term electrical reliability.
