Keynote II. Quality Challenges and Risk Mitigation for Passive Components in Harsh Environments

ABSTRACT

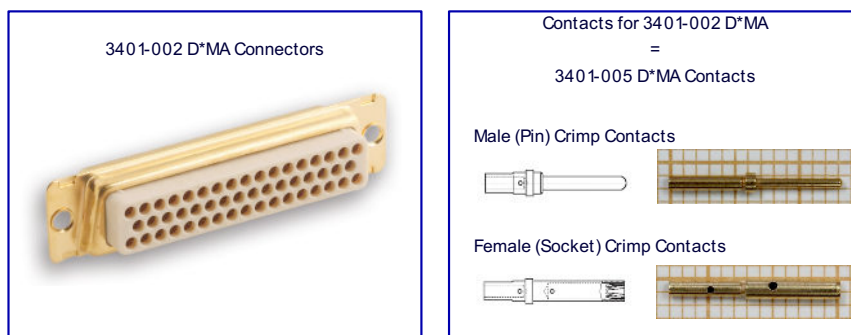
Figure 1 D-SUB CONNECTORS WITH REMOVABLE CRIMP CONTACTS

The issue was detected during incoming inspection after crimping and confirmed by ESA investigation as part of a major project requiring imminent vibration testing.

The defects represented non-compliance with ECSS standards, risking both electrical performance and long-term reliability.

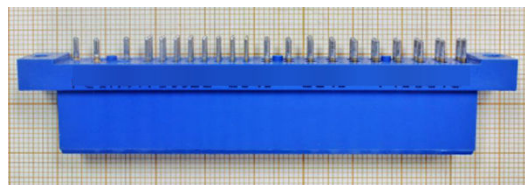
Figure 12 Side view of connector

During the mechanical shock qualification of high-density rectangular PCB connectors used in modular power supply assemblies, one out of three test samples exhibited a critical failure. A socket pin on the female connector cracked following shock exposure along the X-axis. The anomaly was identified during post-test external visual inspection (EVI) and triggered a temporary suspension of the qualification flow for all units of the same lot, which were intended for flight use.

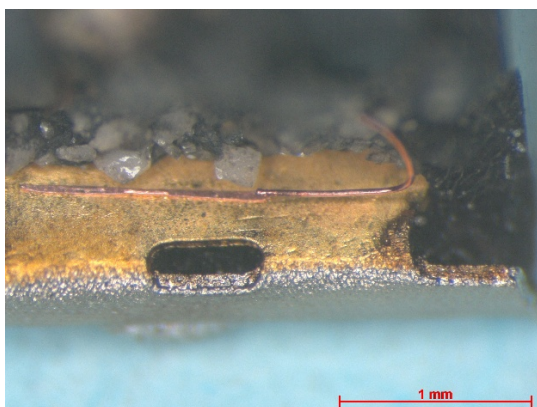
Figure 28

Notably, qualification models assembled manually had not shown this failure, which prompted a detailed failure analysis to determine the effect of production processes on the mechanical reliability of thin-wire components.
